**KOERS
& ASSOCIATES
ENGINEERING LTD.**
Consulting Engineers

September 20, 2023
2338-01

RE: Graham Lake Water Local Service Area
AC Watermain Condition Assessment – Desktop Study

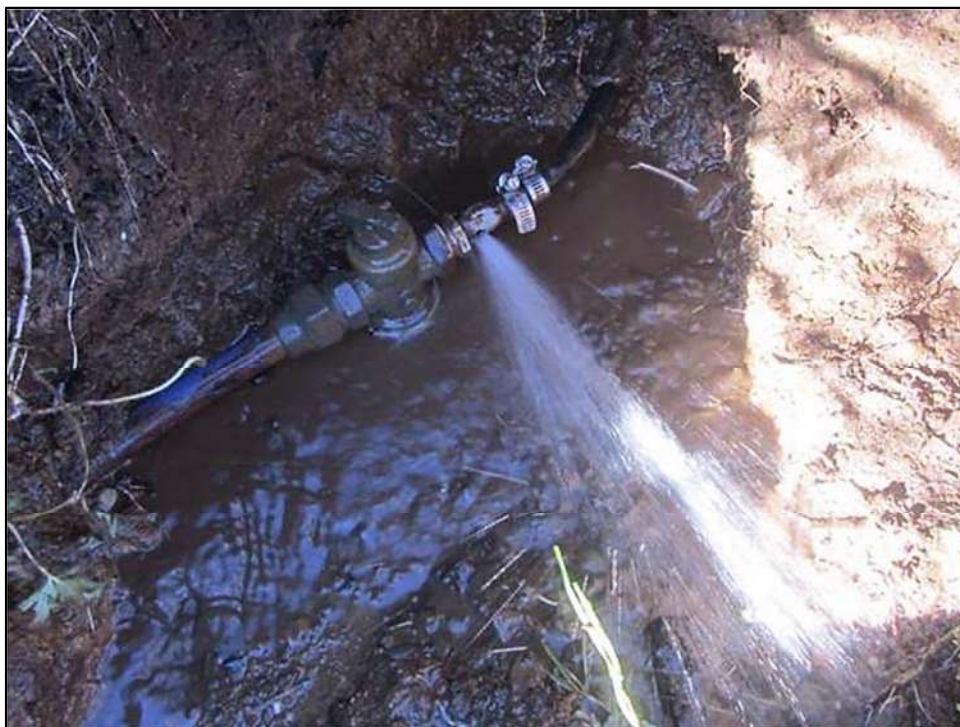
August 28, 2017
3941 East Road – Leak at curb stop, customer side.

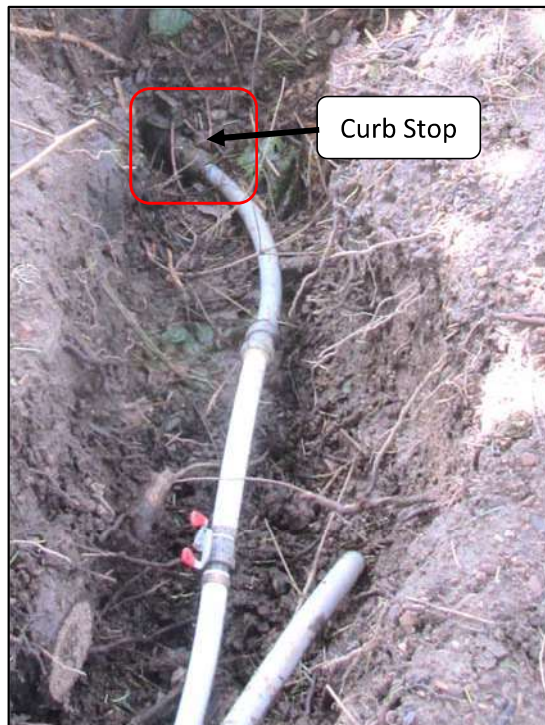
October 13, 2017
3616 East Road – Watermain side.
Repaired 7 ft section of damaged service
line and curb stop.

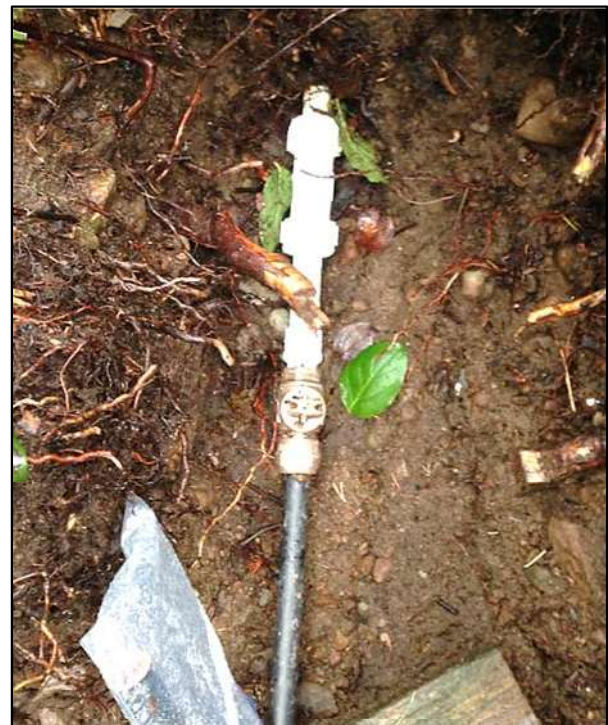
November 29, 2017
4356 East Road - Watermain side
Unusual PVC service connection.
PVC (thin walled) snapped when attempting
to shut off curb stop. Installed compression fitting.

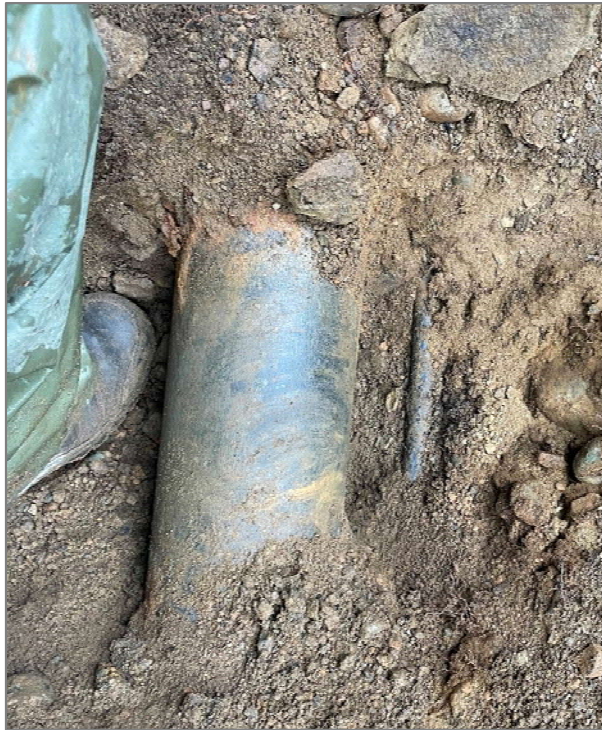
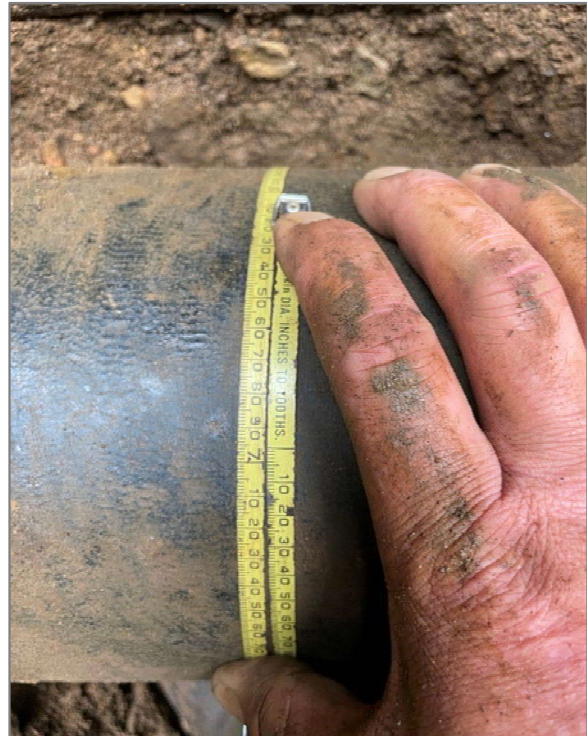
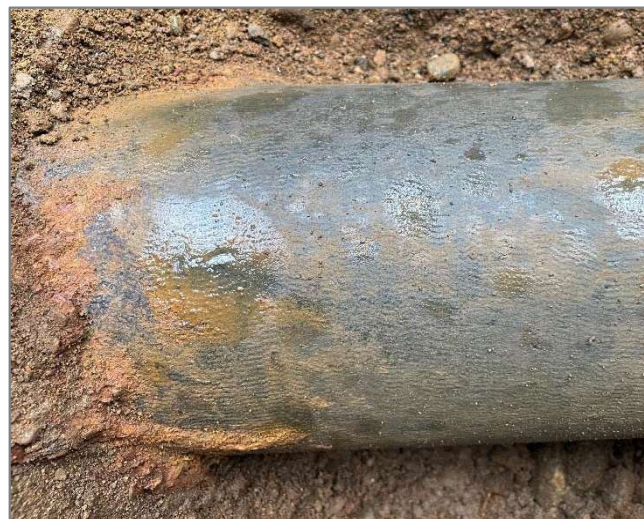
8875 Owl Crescent (front yard)

The supply main was exposed at 8875 Owl Crescent where the As-built drawings indicate the pipe to be AC. The pipe was observed by CVRD staff to be DI with an outside diameter of 6.95 inches. The pipe exterior appeared to be in very good condition with no obvious signs of deterioration of the black coating even though the pipe appeared to have been buried with common backfill i.e., no pipe bedding sand or fine gravel as can be seen in the photographs below.

The static pressure in the main at this location is estimated to be around ± 140 kPa (20 psi).

The pressure rating for this 150 mm dia. Ductile Iron pipe is not known. The 1981 American Water Works Association (AWWA) document C150/A21.50-81 notes a rated working pressure of 2,400 kPa (350 psi) plus a pressure surge allowance of 700 kPa (100 psi) for 75 mm dia. to 450 mm dia. DI pipe.

The small dia. pipe suspected to be the 19 mm dia. connection for the then future hypochlorinator to be constructed at the lake as noted on the July 10, 1972 As-built drawing.

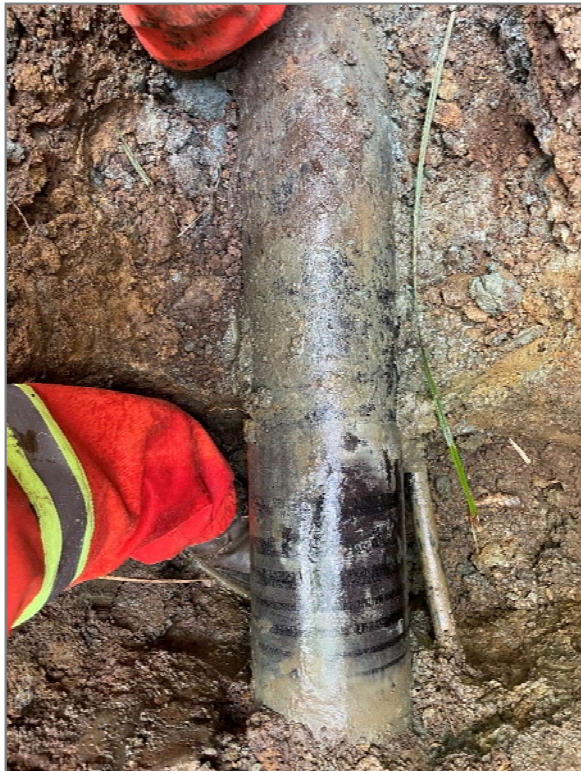
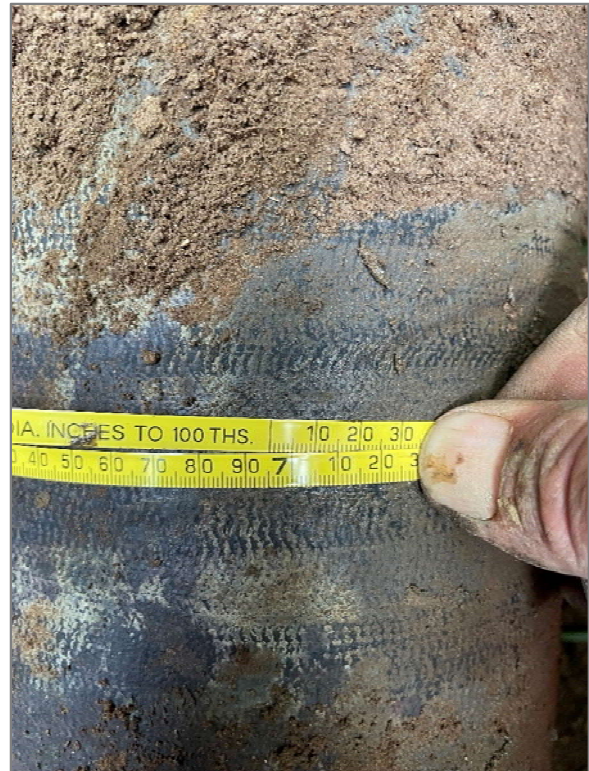
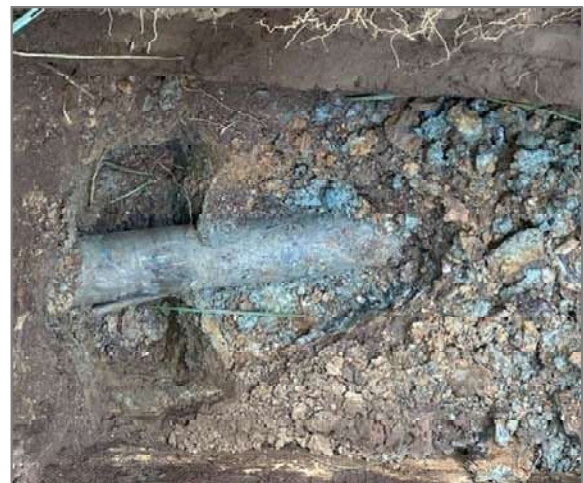
Graham Lake Creek Crossing (rear yard of 8850 Owl Crescent/3525 East Road)

The supply main was exposed at the creek crossing in the area where the As-built drawing showed a 30 m long section of steel pipe. The pipe was found to be 150 mm dia. Ductile Iron with an Outside Diameter of 6.95 inches. The pipe exterior appeared to be in very good condition with no obvious signs of deterioration of the black coating even though the pipe appeared to have been buried with common backfill around the pipe, i.e., no pipe bedding sand or fine gravel as can be seen in the photographs below.

The static pressure in the main at this location is estimated to be around ± 200 kPa (28 psi).

The pressure rating for this 150 mm dia. Ductile Iron pipe is not known. The 1981 American Water Works Association (AWWA) document C150/A21.50-81 notes a rated working pressure of 2,400 kPa (350 psi) plus a pressure surge allowance of 700 kPa (100 psi) for 75 mm dia. to 450 mm dia. DI pipe.

The small dia. pipe suspected to be the 19 mm dia. connection for the then future hypochlorinator to be constructed at the lake as noted on the July 10, 1972 As-built drawing.

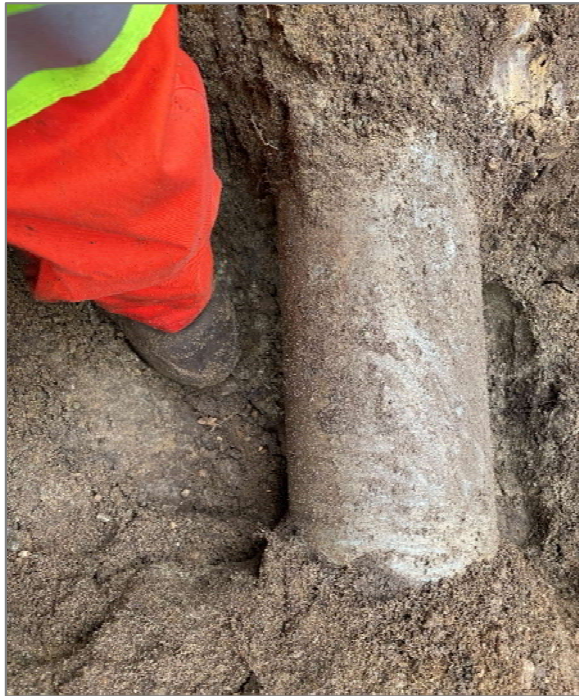
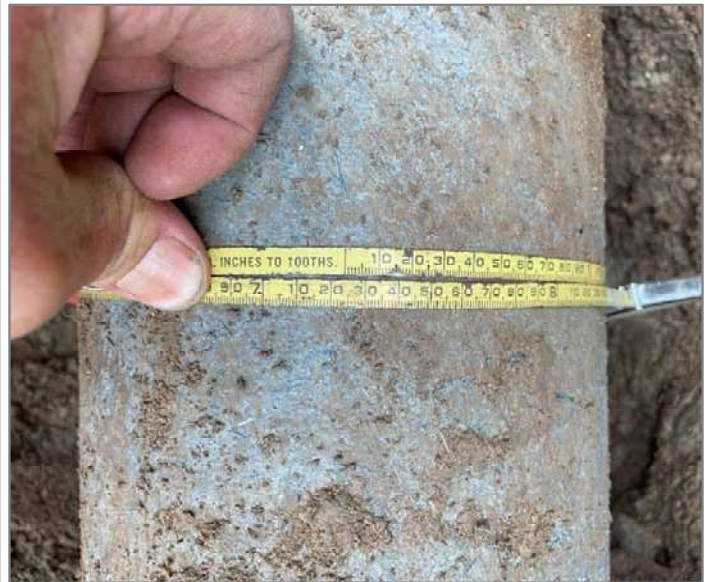
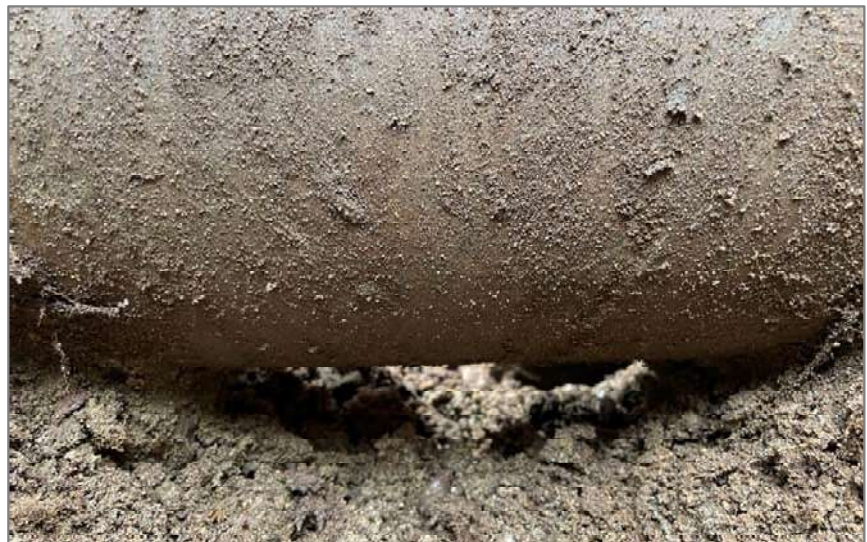
3640 East Rd

The distribution main was found to be 150 mm dia. Asbestos Cement (AC) with an Outside Diameter of 7.25 inches. The pipe exterior appeared to be in very good condition with no obvious signs of damage, saturation, sponginess or loss of material. The pipe appears to be surrounded with a layer of bedding sand or other fine grained material. The As-built drawings noted the pipe bedding to be sand or fine gravel.

The static pressure in the main at this location is estimated to be around ± 380 kPa (55 psi) based on a system pressure of 345 kPa (50 psi) at the pumphouse.

The pressure rating for 150 mm dia. Class 150 AC pipe is 1,035 kPa (150 psi).

AC pipe with low free lime content is reported to have more resistance to moderate amounts of sulphates in the soil. Although it is not known what the free lime content is in the GLWLSA AC pipe, the photographs of the AC pipe at both locations appear to show the exterior pipe wall to be in very good condition.

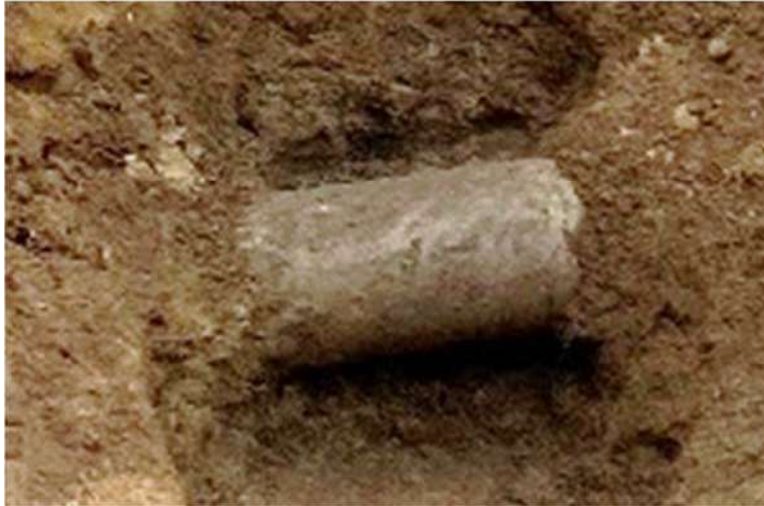
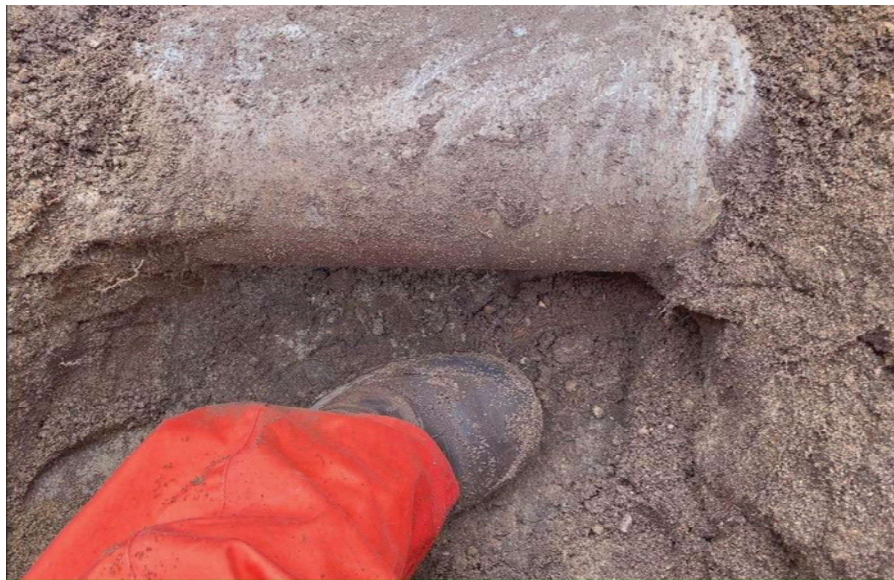
4046 East Rd

The distribution main was found to be 150 mm dia. Asbestos Cement (AC). The pipe exterior appeared to be in very good condition with no obvious signs of damage, saturation, sponginess or loss of material. The pipe appears to be surrounded with a layer of bedding sand or other fine grained material. The As-built drawings noted the pipe bedding to be sand or fine gravel.

The static pressure in the main at this location is estimated to be around ± 500 kPa (73 psi) based on a system pressure of 345 kPa (50 psi) at the pumphouse.

The pressure rating for 150 mm dia. Class 150 AC pipe is 1,035 kPa (150 psi).
