To: Mr. Bill Uhrich  
Simcic + Uhrich Architects  
Suite 230 3 West 3rd Avenue  
Vancouver BC V5Y 3T8

Submitted: May 18, 2017 by  
RDH Building Science Inc.  
730 Grant Avenue #208  
Courtenay BC V9N 2T3

RDH Building Science Inc. (RDH) was retained by Simcic + Uhrich Architects to undertake a targeted investigation of the of the wall assembly located at 3850 Central Rd, Hornby Island, BC.

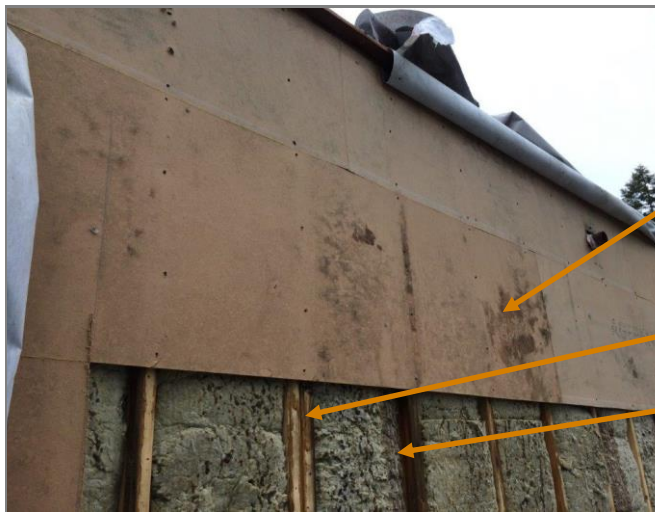
*Figure 1.5*

RDH was contacted by Simcic + Uhrich Architects on April 21, 2017 after the general contractor, Island West Coast Developments (IWCD), observed water running down the outside face of the exposed footing in the storage shed. Prior to RDH attending site, IWCD removed exterior cladding and sheathing above the storage room to expose the stud cavity. Liquid water was reported to have formed on the outboard site of the mineral wool insulation and on the inboard face of the Agepan wood-fiber sheathing. Photos of the conditions were sent to us by Bill Uhrich, refer to Figure 1.5.

*Staining on the outboard face of the Agepan was reported to have occurred during construction*

*Studs and sheathing found to have high moisture content.*

*Moisture observed on the outboard face of the insulation and back face of the Agepan sheathing*

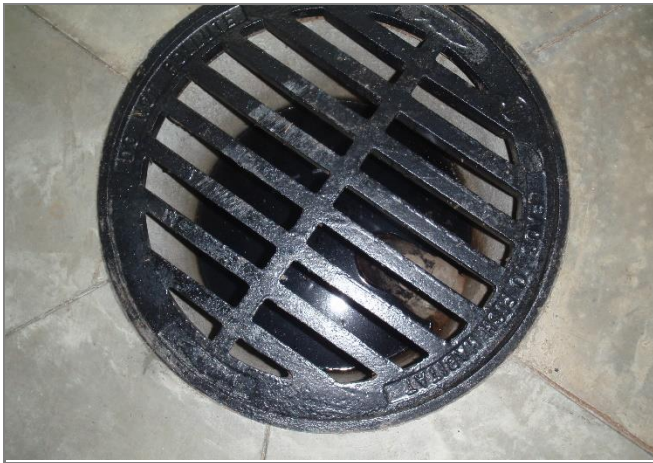
*Figure 2.1*

We observed five catch basin type drains in the Apparatus Bay. Most of the basins were partially filled with water, refer to Figure 2.1.

*One of 5 catch basins in the Apparatus Bay.*

Although we have not reviewed the mechanical drawings, we understand there is no provision for mechanical exhaust ventilation in the bays other than the truck engine exhaust system specific to each bay section, refer to Figure 2.2. The catch basins create an open source of moisture in the apparatus bay that will lead to elevated humidity. Together with the drying of wet equipment in the bays, it is anticipated the interior humidity will be higher than normal. The seals around the overhead doors act as baffles for wind driven rain, but do not appear to be air tight. Therefore, there will likely be some air exchange with the outside.

We recommend that the interior humidity be monitored during operation of the building. To control high humidity, consider integrating a humidistat control with the ambulance fume exhaust fan.

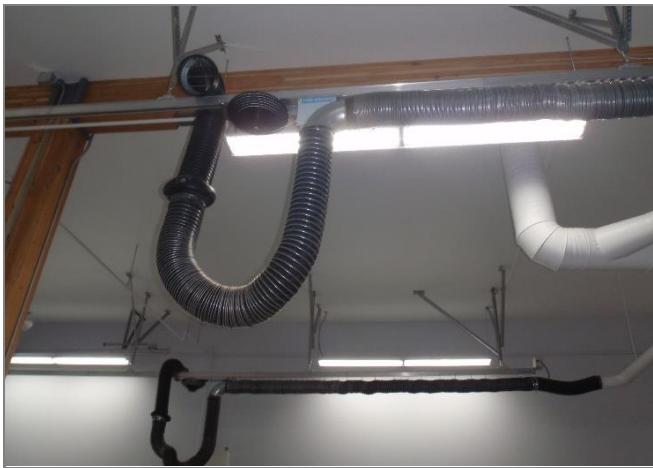
*Figure 2.2*

*Truck exhaust connections.  
Fumes evacuated through roof  
top mechanical unit.*

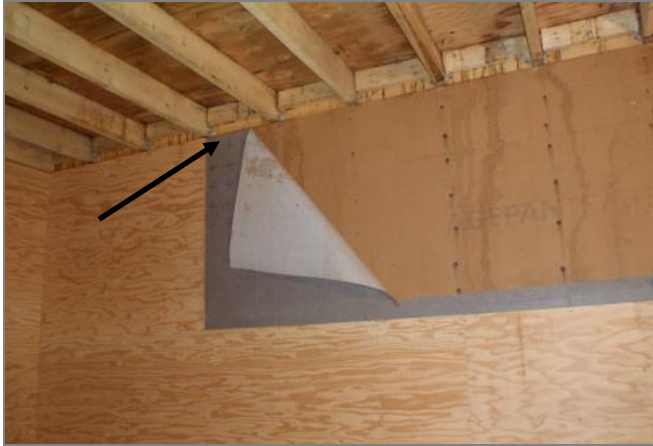
*Figure 2.4*

- Based on our review of the field installation, the air barrier strategy is not clear. The exterior sheathing membrane is discontinuous at numerous locations including penetrations, storage shed roof ledger and base of wall, refer to Figure 2.4.

*The sheathing membrane terminates at the underside of the roof ledger in the unheated storage room.*

- Seal terminations and membrane transitions to other substrates.
  - Ensure continuity of the membrane and seal all penetrations.
  - Seal all joints in the unheated storage room roof ledger attached to the Apparatus Bay wall. Seal the ledger to the water resistive barrier sheathing membrane.

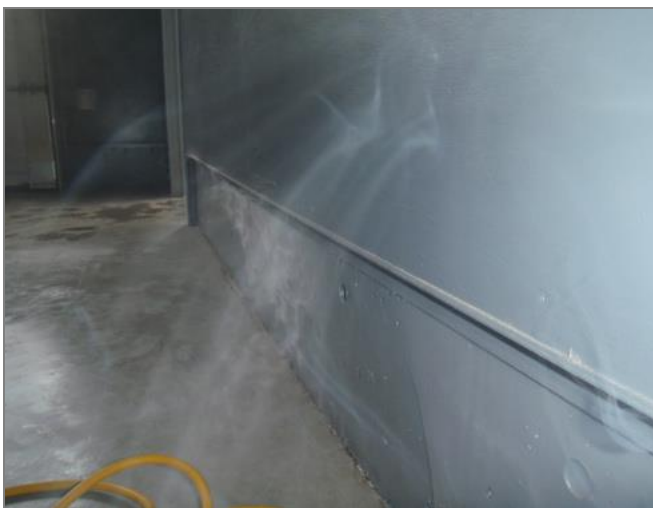
*Figure 2.5*

- The interior sheathing air barrier/vapour retarder is not continuous. The interior sheathing is scheduled to act as the vapour retarder and we understand taped to be the primary air barrier. Several discontinuities in the OSB/plywood sheathing were observed including:
  - joints in the OSB or plywood sheathing were not sealed
  - penetrations through the sheathing such as interior outlets and fixtures were not sealed to the OSB
  - the base of wall transition to the concrete foundation was not sealed, refer to Figure 2.5.

We understand that plywood sheathing was used in place of the OSB in portions of the wall area. Plywood does not provide the same vapour resistance at OSB and even less when damp.

*Smoke was injected into the wall through the two interior electrical outlets in the north wall of the Apparatus Bay. Smoke was observed streaming out the base of wall joint.*

- Seal the joint between the interior wall finish and the concrete foundation (joint currently covered by a metal closure).
- Install a vapour retarder paint on to the surface of the interior plywood and gypsum wall finish to achieve a wet cup vapour permeance of  $60\text{ng}/(\text{Pa}\cdot\text{s}\cdot\text{m}^2)$  or less to reduce amount of moisture that is able to diffuse into the wall cavity given the expected operating conditions and humidity within the Apparatus Bay.

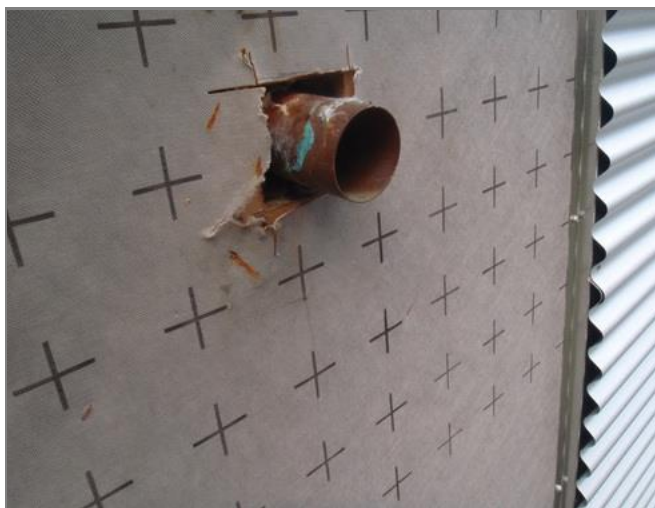
*Figure 2.6*

- The seal between the exterior water resistive barrier sheathing membrane and wall penetrations is inconsistent. We found several penetrations including roof scuppers and electrical wiring through the sheathing membrane that were not sealed, refer to Figure 2.6. Deficiencies were identified when the wall cladding was removed at exterior opening locations. Based on the widespread pattern of wetting at the top half of the wall along the North elevation these deficiencies have not likely contributed to the moisture issues due rain water leakage, however are recommended to be properly sealed to reduce this risk.

*Sheathing membrane that forms the water resistive barrier not sealed to penetrations.*

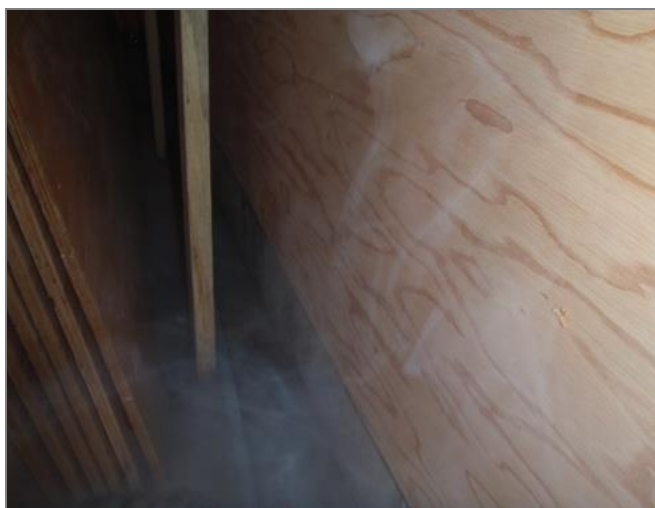
*Figure 2.7*

- Testing uncovered that the Ampatop water resistive barrier is not fully sealed to the foundation wall. Smoke was injected into the interior outlet opposite the unheated storage area using a Rosco 1900 fog machine. The smoke was forced into the wall with an in-line fan in the smoke tube. Smoke was observed streaming out of the base of wall in the exterior storage room, refer to Figure 2.7. The smoke identifies potential air leakage paths indicating that the interior sheathing (air barrier/vapour retarder) has not been connected to the base of wall. Air leakage across the wall can also draw moisture laden air into the wall.

*Smoke was observed streaming out the base of wall joint within the unheated storage room when smoke was injected into the wall through an interior electrical outlet.*

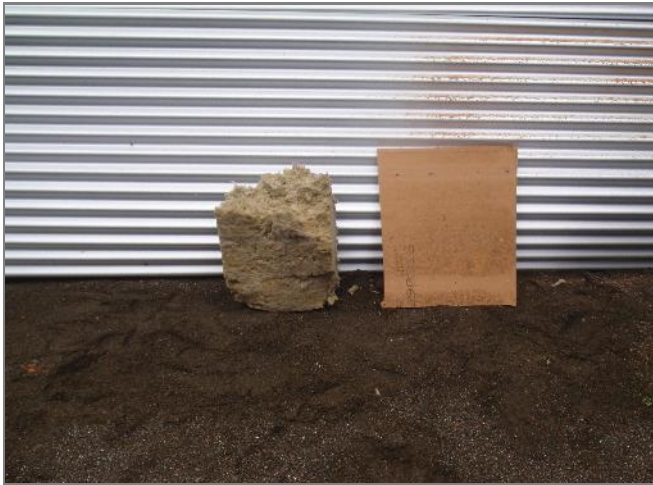
*Figure 2.8*

- Black staining which appears to be fungal growth on the inboard side of the Agepan was observed at the top and bottom of the samples removed in the exploratory openings. Even in the lower wall areas with low moisture content in the wood components there was some staining observed, refer to Figure 2.8.

*Black staining on the inboard side of the Agepan. Sample taken from lower portion of wall.*

- Dry out the wall.
  - At the Apparatus Bay walls remove at least the top 6 feet of cladding, Agepan sheathing, and insulation to dry out the interior stud cavity.
  - Clean and treat all fungal growth from within the wall cavity and dispose or clean all Agepan sheathing with existing staining or fungal growth.
- Correct air barrier discontinuities and provide vapour control.
  - Seal penetrations through the interior wall finishes including outlets and fixtures. This can potentially be performed from the exterior side of the interior sheathing or at the interior of the Appartus bay space by sealing the sheathing .

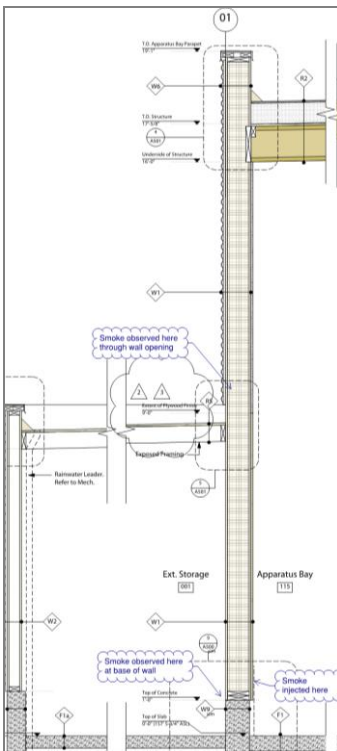
*Figure 2.9*

- We performed smoke testing of the wall assembly at targeted locations including the two interior electrical outlets at the base of the wall. Smoke was injected past the outlet using a Rosco 1900 fog machine. No pressure differential was imposed on the wall other than ambient weather conditions. The smoke was forced into the wall with an inline fan within the 4 inch smoke tube. When smoke was injected past the interior outlet at Gridline 1/C smoke was observed in the stud cavity above the unheated storage room, refer to Figure 2.9.

*Small amount of smoke observed at the blocking in the stud wall above the storage roof during the smoke test at the interior outlet below.*

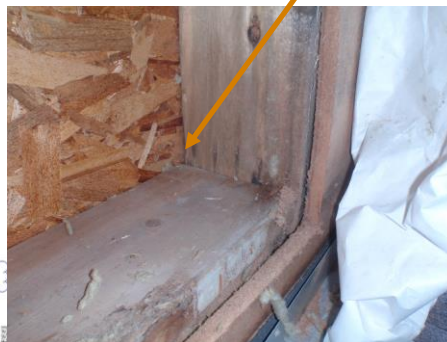
*View from the exterior opening above the unheated storage room.*

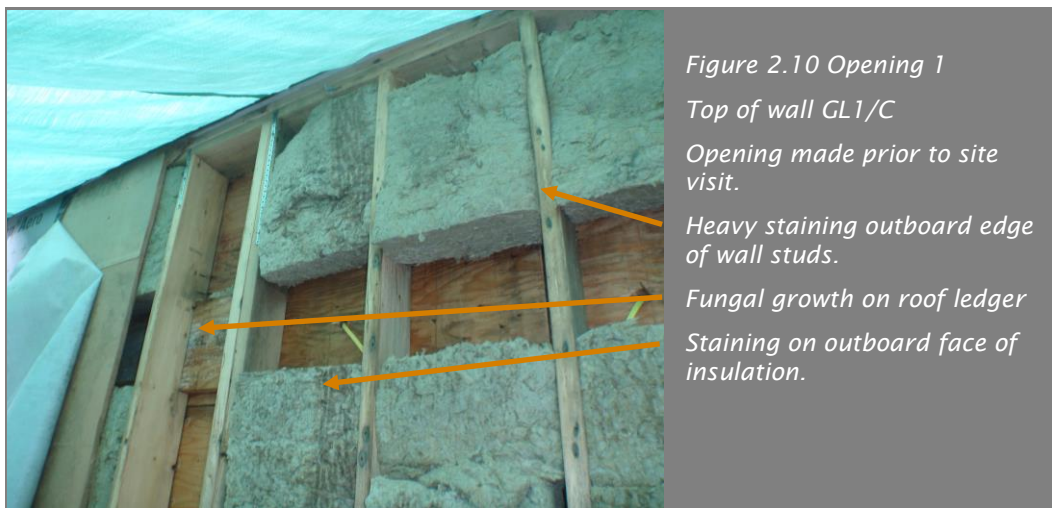
→ Significant black staining/fungal growth within the stud cavity was observed at Exploratory Opening 1, refer to Figure 2.10 below in Section 2.3.

Opening 1 was made by IWCD prior to our site visit and as a result of staining observed at the base of wall below the opening. IWCD indicated that wet insulation and studs were observed when the wall assembly was opened up.

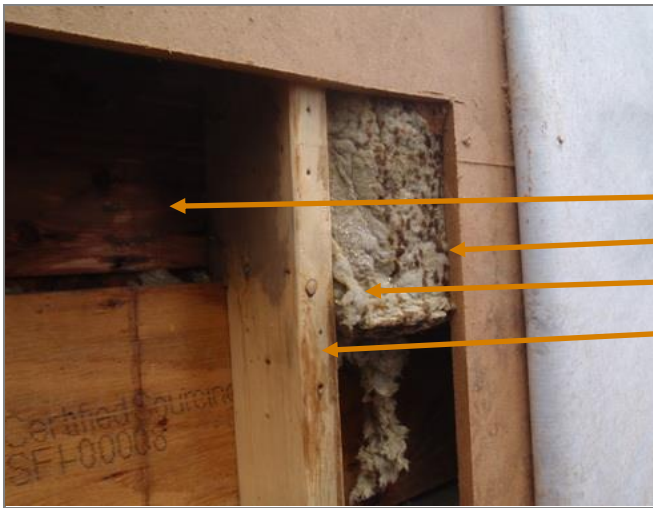
This exploratory opening was made by IWCD during our site visit. The opening was made at the parapet height near the roof level interface. We observed moisture droplets on the face of the mineral wool insulation. The moisture content in the plywood sheathing on the inside face of the parapet was found to be 40% indicating the wood is saturated. The majority of the parapet plywood would be cold due to the uninsulated inside parapet face above the roof level.

*Figure 2.11 Opening 2  
Top of wall GL 1/G  
Moisture Content Readings  
40% MC plywood at parapet  
40% MC back side of Agepan  
Wet insulation  
25% MC outboard face of stud*

- Add air-sealed horizontal blocking in the wall cavity to separate the parapet from the wall cavity.
- Install passive vents into the parapet space venting into the rain screen cavity behind the metal cladding.

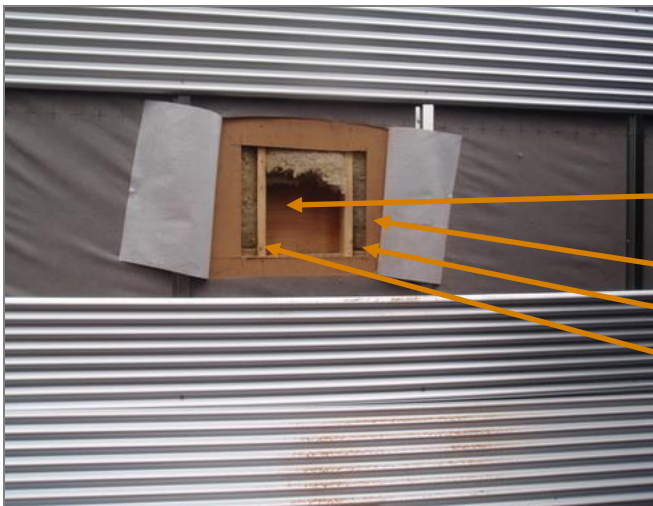
This exploratory opening was made by IWCD during our site visit located directly below opening 2 at the base of the wall. We found that the insulation was dry at this location along with the other wood wall components. We observed staining on the backside of the Agepan sheathing.

*Figure 2.12 Opening 3  
bottom of wall GL 1/G  
Moisture Content Readings  
10% MC plywood interior sheathing  
20% MC back side of Agepan  
dry insulation  
17% MC outboard face of stud*

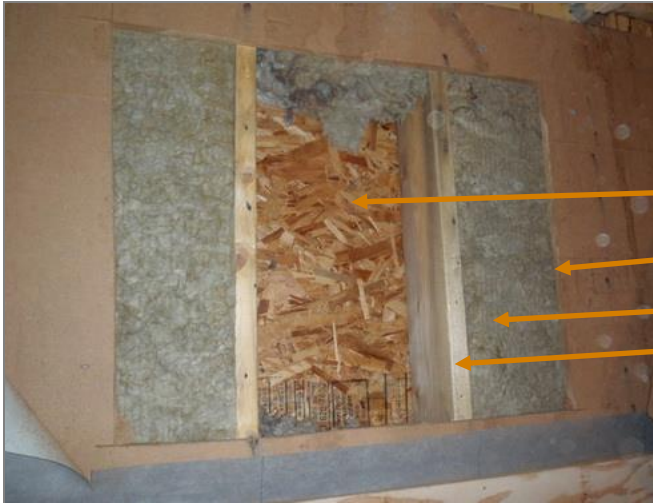
This exploratory opening was made by IWCD during our site visit directly below opening 1 inside the unheated storage room. We found that the insulation was dry at this location along with the other wood wall components. We observed staining on the backside of the Agepan sheathing.

*Figure 2.13 Opening 4  
bottom of wall GL 1/D  
Moisture Content Readings  
10% MC OSB interior  
sheathing  
20% MC back side of Agepan  
dry insulation  
17% MC outboard face of stud*

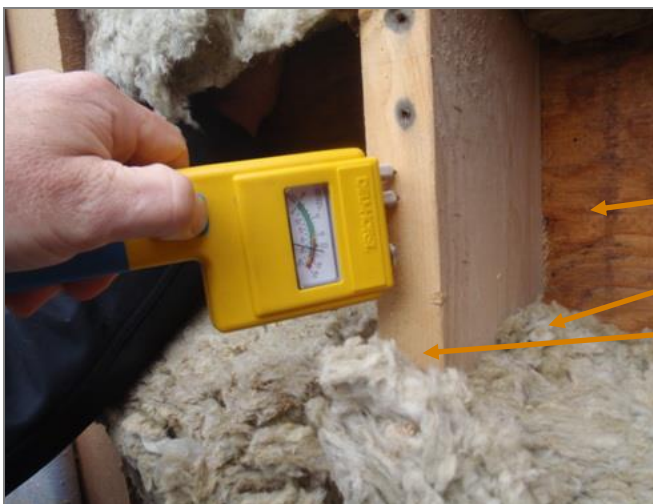
Opening 5 was made by IWCD during our site visit above the level 2 roof deck. We found the face of the mineral wool insulation to be damp. The moisture content in the plywood sheathing on the inside face of the parapet was found to be 30%. Staining was observed on the plywood sheathing. The back side of the Agepan was also found to be wet and stained.

*Figure 2.14 Opening 5  
Top of wall GL 4/B  
Moisture Content Readings  
30% MC plywood at parapet  
35% MC back side of Agepan  
Damp insulation  
22% MC outboard face of stud*

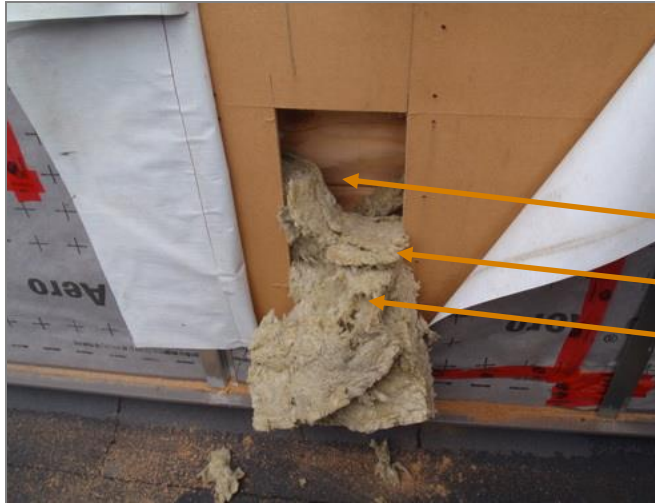
*Figure 2.15 Opening 6*

This exploratory opening was made by IWCD during our site visit directly below opening 5 above the level 2 roof deck. We found that the insulation was dry at this location along with the other wood wall components. We observed staining on the backside of the Agepan sheathing.

*Bottom of wall GL 4/B above roof deck.*

*Moisture Content Readings*

*19% MC plywood interior sheathing*

*20% MC back side of Agepan dry insulation*

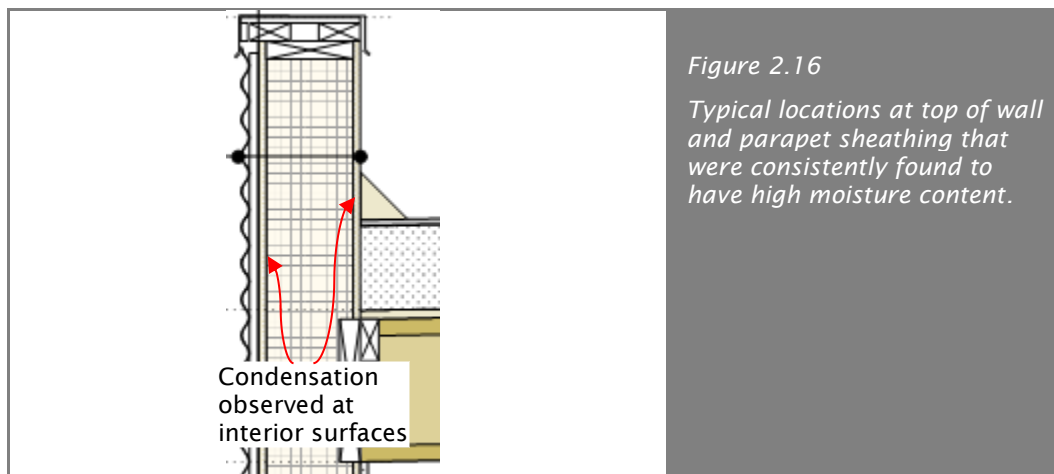
The high moisture content found along the top half of the wall does not appear to be caused solely by the discontinuities in the air and vapour barrier. We understand that the construction of the Apparatus Bay occurred during the winter months and was exposed to inclement weather before being covered. In combination with the unheated Apparatus Bay, latent construction moisture in the stud cavity is condensing on cold surfaces, mainly the parapet and has not dried out and is collecting in the upper wall leading to staining and fungal growth on the wet wood materials.

Varying levels of staining and fungal growth on the in-board side of the Agepan was identified at all exploratory openings indicating there was moisture accumulation to some degree across the entire wall area. The moisture has now accumulated at the top of the wall condensing on the inboard side of the Agepan sheathing and parapet sheathing, refer to Figure 2.16.
