# **HORNBY ISLAND FIRE HALL**

## **OPTION ANALYSIS**

**Prepared for  
Comox Valley Regional District  
October, 2008**

**By  
Fletcher Pettis Consultants Ltd**

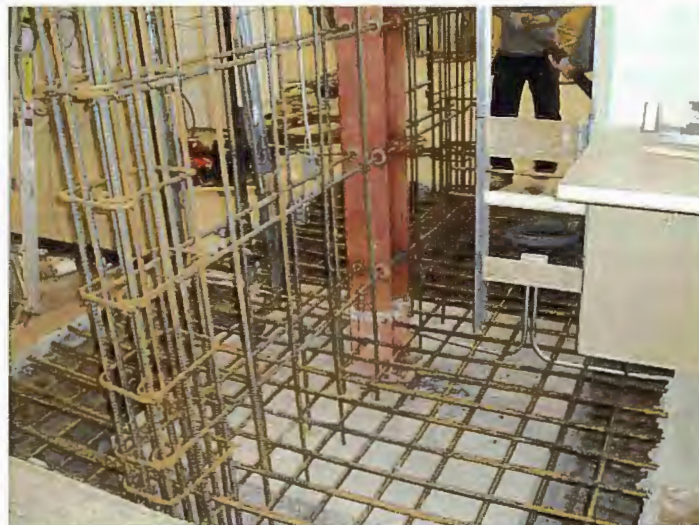
*Example retrofit with installation of new foundation and steel reinforced shear wall.*

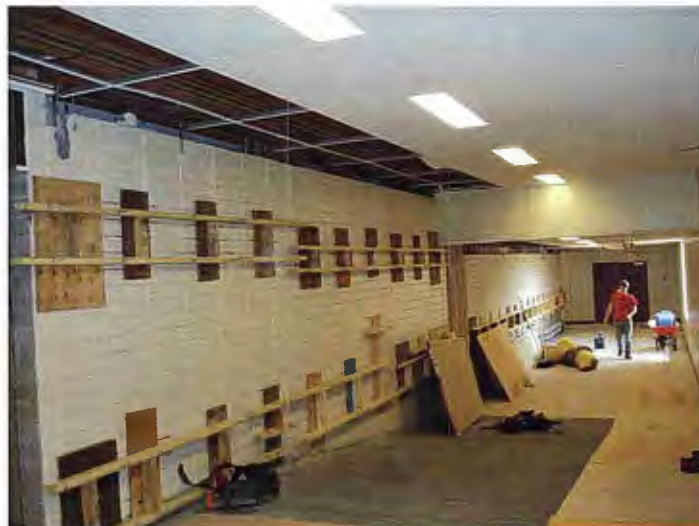
*Example of block wall receiving steel reinforcing bars and grout*

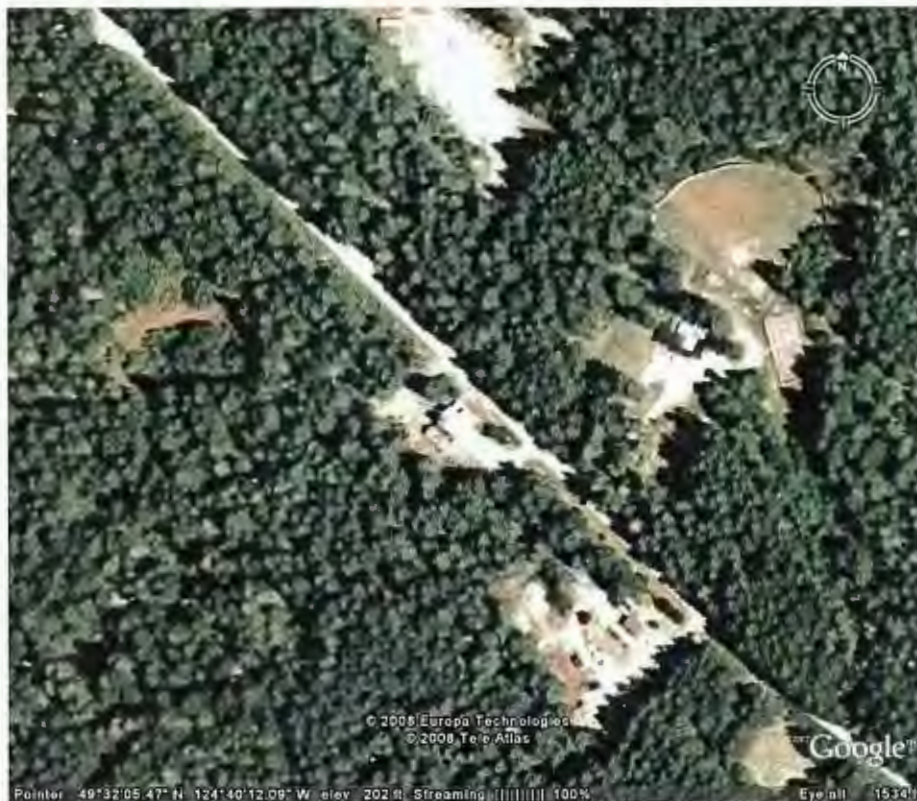
*Air photo of Fire Hall and Joe King Park*

No survey information was available or obtained for this study therefore lot lines were roughly taken off fencing on adjacent properties and IMap information. The site is approximately 1.12 acres in area with a 198 ft frontage and a 240 ft lot depth. The site must provide for space for a sewage treatment system and disposal field as well as water well. The only vacant space is uphill in the wooded area. The required distance between well and disposal fields is usually a minimum of 50 feet, but it is assumed that to get separation the well would have to go near the front of the lot and downhill from the disposal field. This may be an issue with respect to contamination.

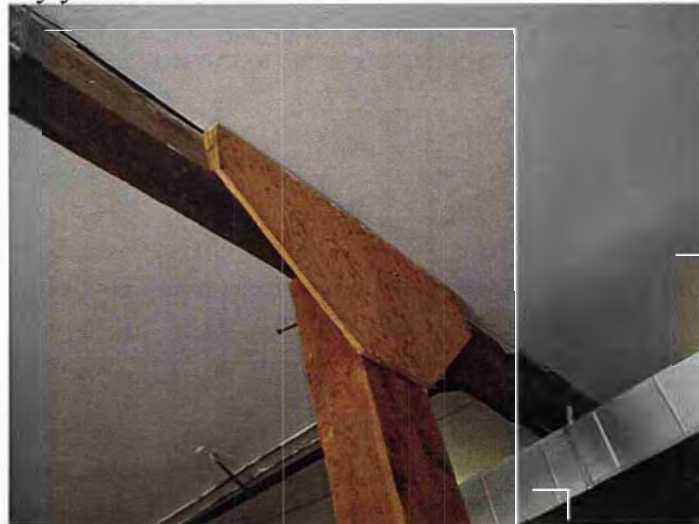
*Hornby Fire Hall – inadequate gusset connection of column to beam supporting second floor.*

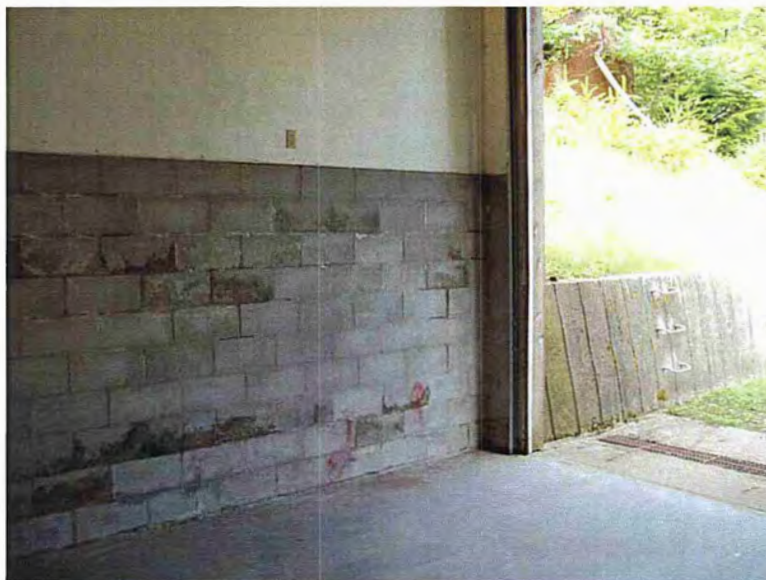
- 8. The southwest masonry retaining wall and foundation at the exterior of truck bay #4 is not adequate for seismic loading from the soil. “*

Hornby Is Fire Hall – soil to be removed from contact with wall and exterior buttresses to be constructed on exterior side.

The seismic report recommends that the slope abutting Bay 4 needs to be excavated to keep seismic forces from being transmitted into the structure. New space needs to be constructed to provide for functional deficiencies. As indicated previously, the lot is only about 198 feet wide. The only area for construction is therefore uphill in an area that likely cannot fit the services mentioned above. As well, Fire Department personnel indicate that the needed spaces must be contiguous to the existing hall and at the same level as the remainder of the hall.
