Biophysical Assessment- Montrose Park

To:	Mark Hart, CVRD	Date:	September 12, 2025
From:	Dusty Silvester, R.P.Bio. Aaron Tutt, B.Sc., ISA Certified Arborist	Pages:	24 + Appendices
Cc:	CVRD Planning Department	Project:	2444

RE: BIOPHYSICAL ASSESSMENT – CVRD Montrose Park, Courtenay, BC

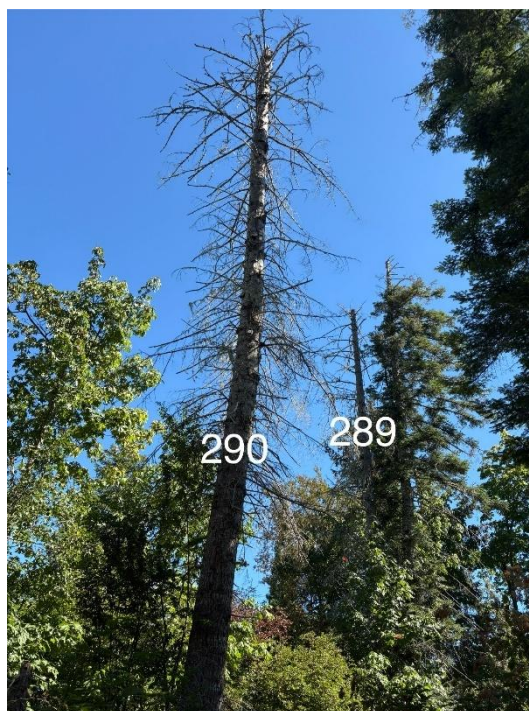
1. Pileated Woodpecker: Several potential cavity trees were observed (Trees #271, 273, 289). Nest trees are protected under the *Migratory Birds Regulations* for three years after abandonment.

2. Bats: Tree # 290 contained loose bark with bat roosting potential. Several bat SAR are known to occur in the region.
3. Other passerine birds: Cavity and feeding opportunities are present across several wildlife trees on site.

Photo 1. Trees #289 and #290 – Grand firs with notable habitat features. Tree #289 exhibits potential pileated woodpecker cavities near the top of the east stem, while Tree #290 displays loose bark that may provide roosting habitat for bats.

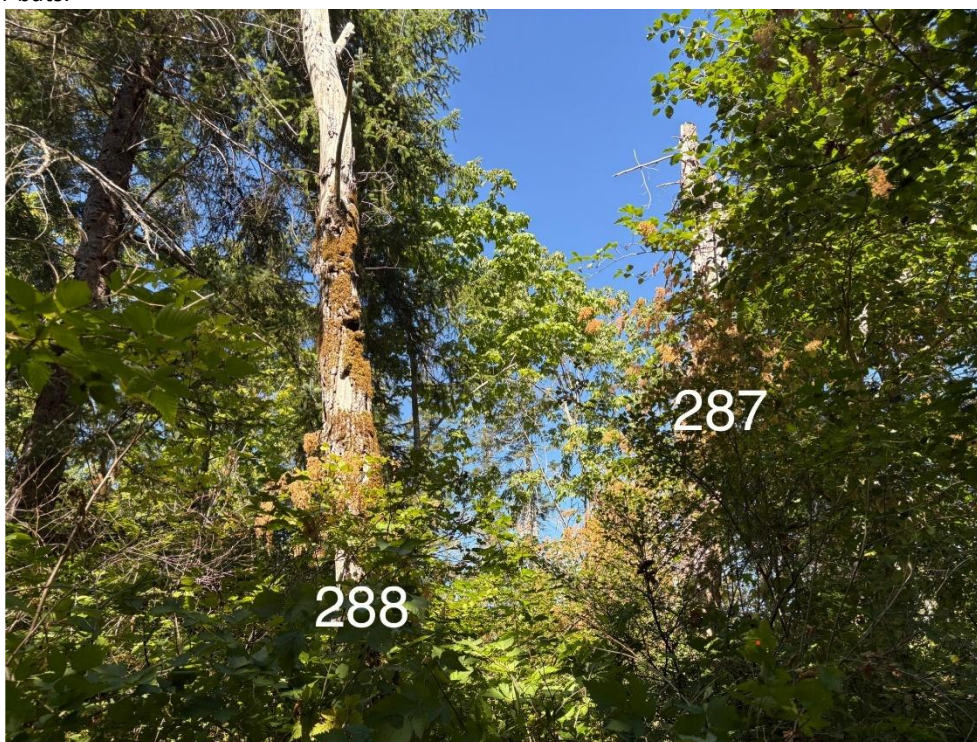
Photo 2. Trees #287 and #288 –Tree #287 (Douglas-fir) is spongy with no cavity value, while Tree #288 (bigleaf maple) is structurally compromised. Both present risk depending on proximity to targets.

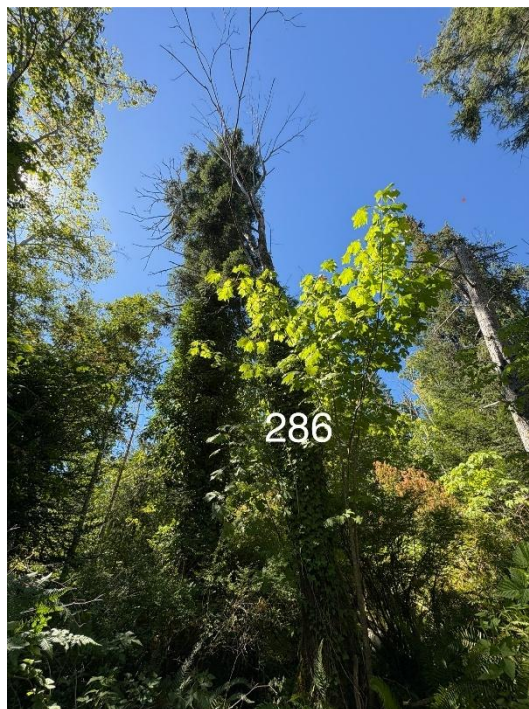
Many other maples were severely compromised by *K. deusta* decay, including Trees #274, 275, 282, 283, and 286. *K. deusta* is a soft rot fungus that preferentially degrades cellulose, often resulting in a brittle tree structure prone to sudden failure. As such, these stems are structurally unstable and considered dangerous depending on proximity to targets. While such trees may retain some short-term foraging or cavity value, their long-term habitat contribution is limited, and retention should only be considered in low-use areas where public safety risks are minimal.

Photo 3. Tree #286 – A declining bigleaf maple with *K. deusta* at the base and limited live crown. Structurally unstable with minimal long-term habitat value.

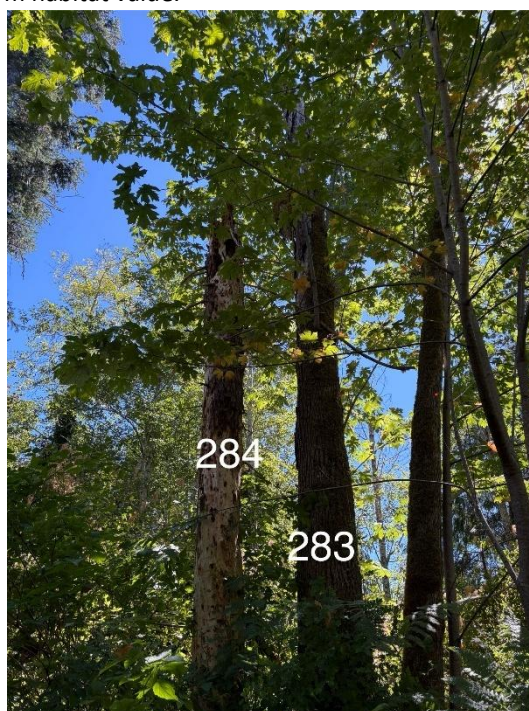
283	-	Bigleaf maple	<i>Acer macrophyllum</i>	115	15	<i>K. deusta</i> at base, main stem top blew out at 10 m, 10 cm deep crack between main trunk and secondary stem, dangerous depending on targets.	Y	-
284	WT4	Grand fir	<i>Abies grandis</i>	47	7	Feeding cavity tree, very punky, close to falling.	Y	-
285	WT3	Western hemlock	<i>Tsuga heterophylla</i>	59	10	20 degree lean to the NE, dangerous depending on targets.	Y	-
286	-	Bigleaf maple	<i>Acer macrophyllum</i>	50	16	<i>K. deusta</i> at base, largely dead with the exception of lower epicormic growth.	Y	-
287	WT1	Douglas-fir	<i>Pseudotsuga menziesii</i>	46	9	Spongy, no nesting value.	Y	-
288	WT2	Bigleaf maple	<i>Acer macrophyllum</i>	41	10		Y	-
289	WT14	Grand fir	<i>Abies grandis</i>	97	25	East stem dead with potential pileated cavities near top, west stem 60% with dead top.	Y	CN
290	WT13	Grand fir	<i>Abies grandis</i>	61	21	Loose bark for bat habitat	Y	CN

Photo 4. Trees #283 and #284 – Severely decayed stems. Tree #283 (maple) has a failed top and a deep longitudinal crack between stems, while Tree #284 (grand fir) is punky with cavity potential but nearing collapse.

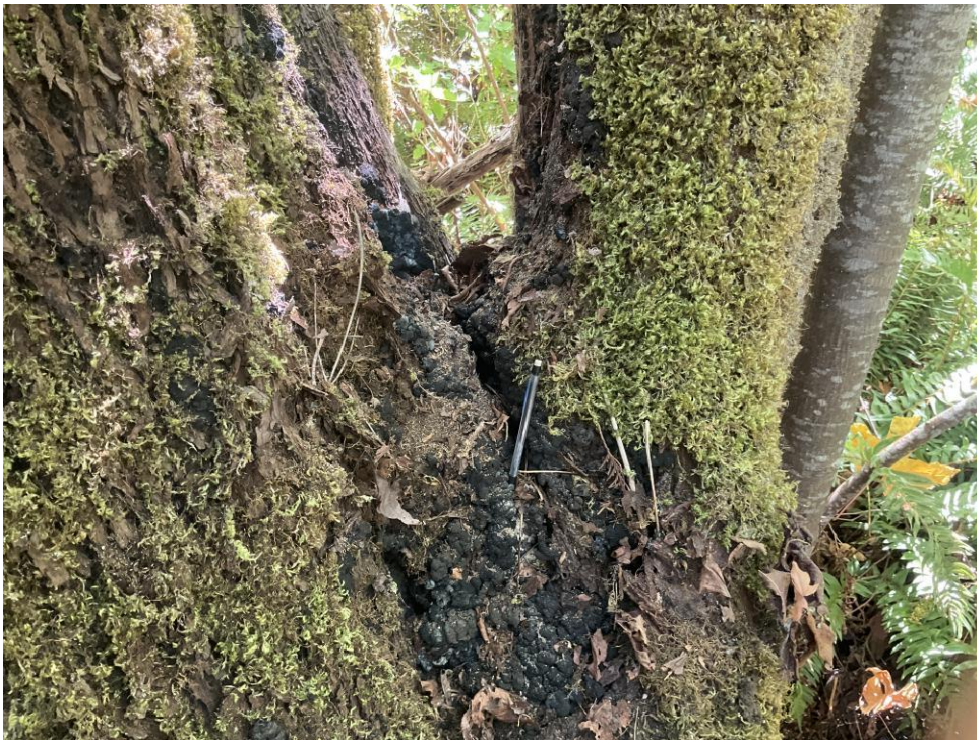
Photo 5. *K. deusta* fruiting bodies observed at the base of Tree #283, illustrating the fungal pathogen responsible for widespread structural decline across the stand.

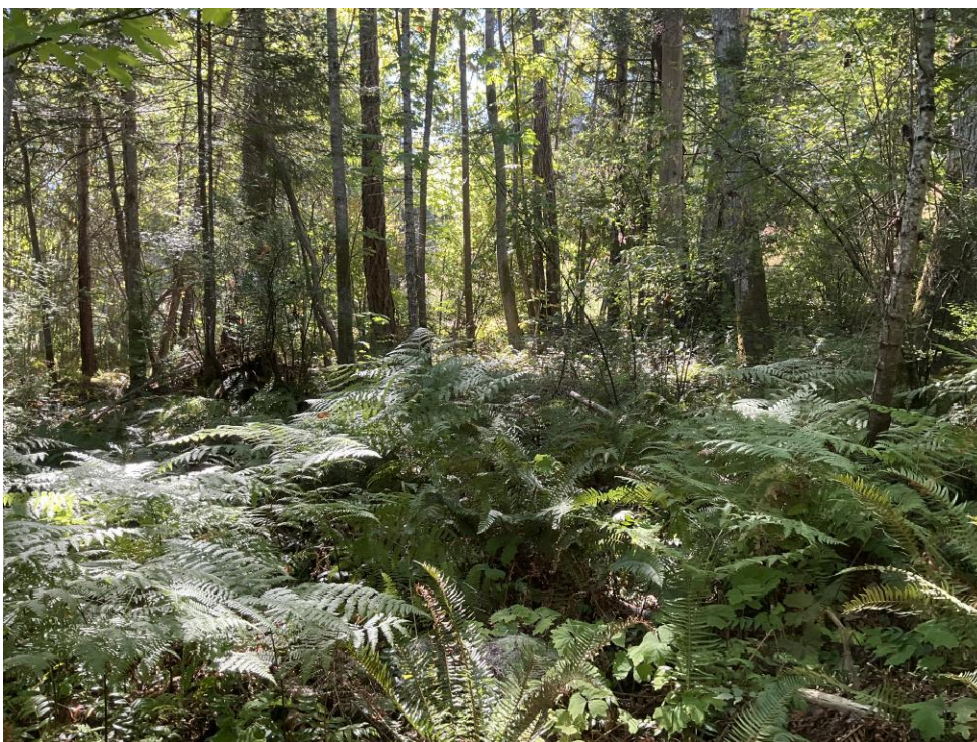
canopy compared to the interior portions of the site. While *K. deusta* is also present in maples within this strip, the overall stand structure is more stable, with a vertical canopy profile and mature conifer presence that provide greater long-term ecological value than the largely degraded interior. The relative value of this upland stand is based primarily on canopy cover, structural diversity, and the presence of longer-lived conifers that contribute to stand resilience.

Photo 6. The upland forest along Highway 19A. Higher-value mixed Coastal Douglas-fir stand with stable canopy and long-term ecological value. This strip is recommended for retention as a buffer.

- b. Retention of the 25–30 m upland forest strip along Highway 19A is also recommended. This zone provides long-term ecological stability, wildlife habitat, and visual buffering from the highway. Constructing a trail through this forest is considered low impact.

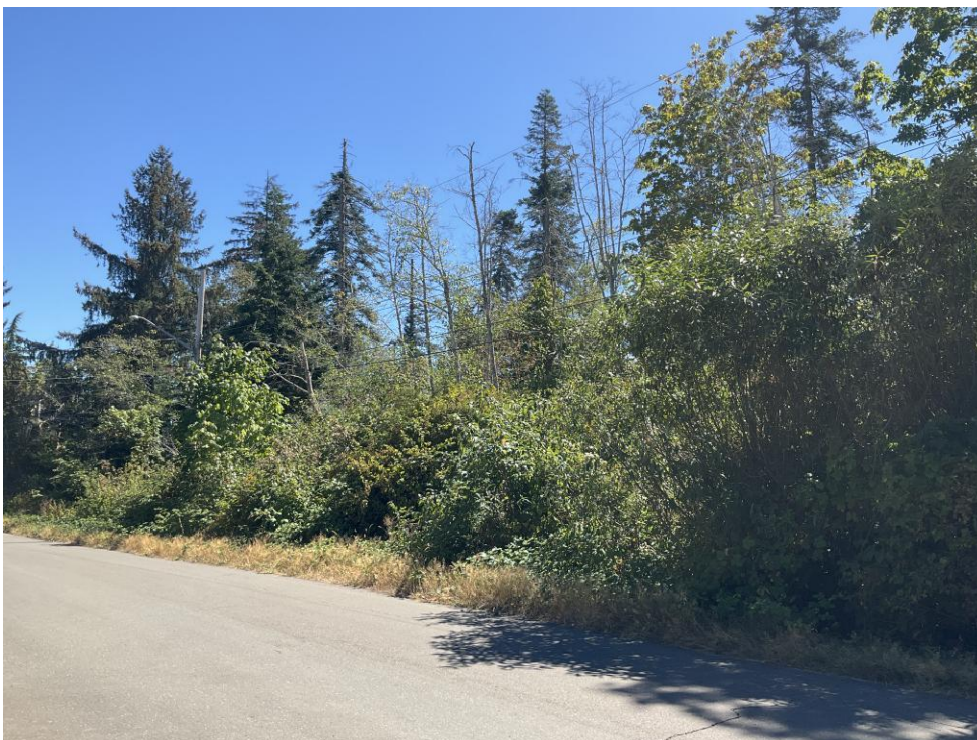
Invasive species are also present within the park. Himalayan blackberry (*Rubus armeniacus*) was recorded in dense patches along Montrose Drive and in interior openings where canopy cover is limited. Recommendations for their maintenance are discussed in Section 6.

Photo 7. Showing Himalayan blackberry along the Montrose Drive ditch (foreground). Targeted removal and replacement with native shrubs is recommended.

- 2) Mitigation would include pre-clearing nest checks for birds and bats.
- 3) Invasive species are recommended for removal and replacement with native species.

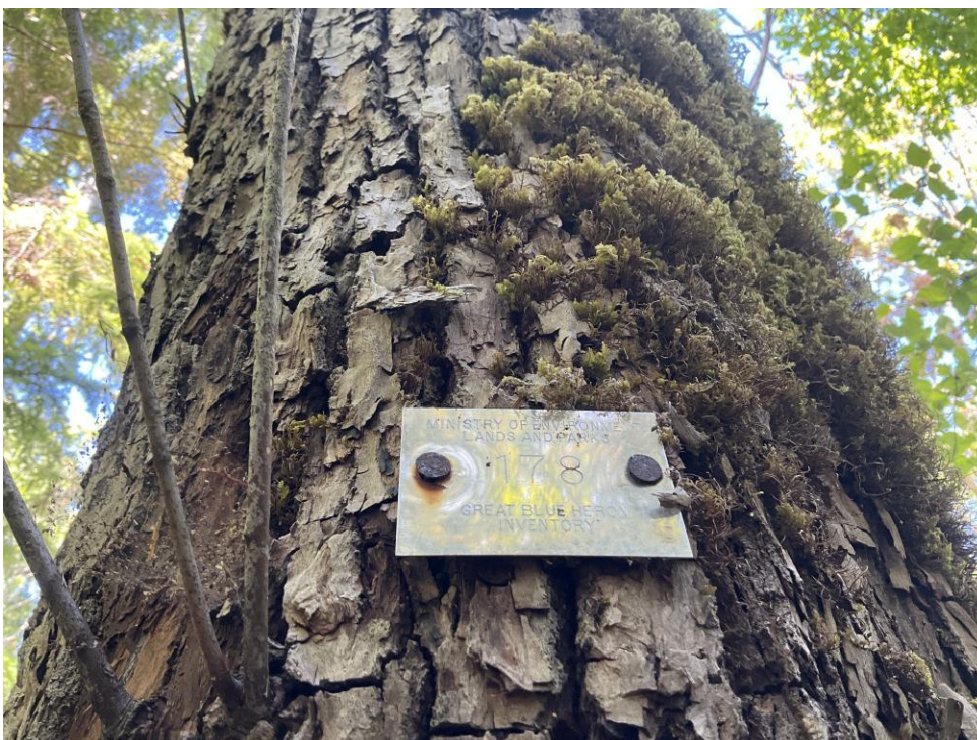
5. Great Blue Heron: Tree #280 contained an inventory plaque, though no nests were observed. This is a historical record that should not constrain work on site if no contemporary nests are present.

Photo 8. Tree #280 with Great Blue Heron inventory tag (178). No nests were present.

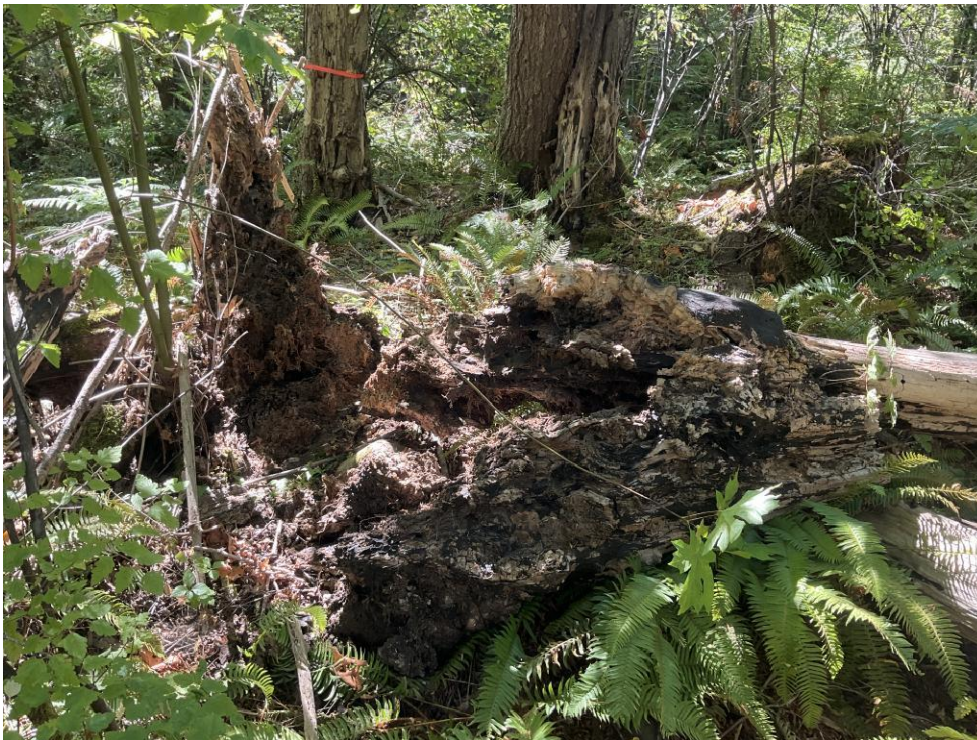
Photo 9. An example of base failure associated with *K. deusta*, demonstrating the hazard profile of many maples within Montrose Park.

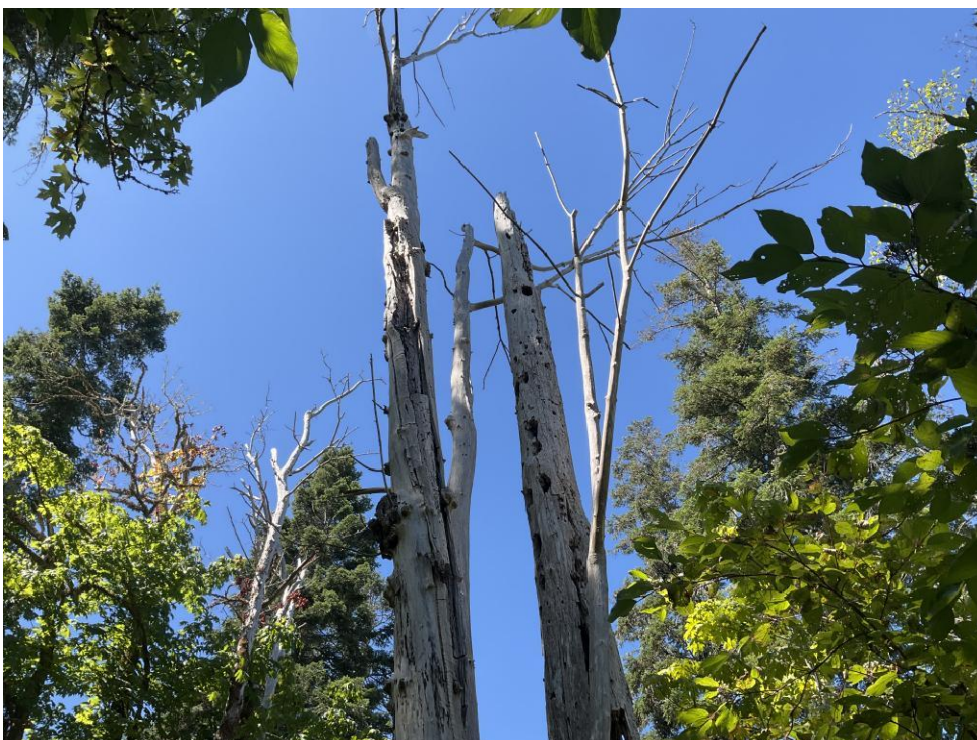
Photo 10. Tree #273 – Bigleaf maple with a potential pileated woodpecker cavity approximately 7 m above ground. A large vertical crack below the cavity suggests declining structural integrity, and therefore, short-term ecological value.
