# PILOT PLANT STUDY CARTRIDGE FILTRATION AND RESIN ORGANICS TRAP

GRAHAM LAKE IMPROVEMENT DISTRICT

PROJECT NO. D-C6100.00  
DATE: NOVEMBER 15, 2019

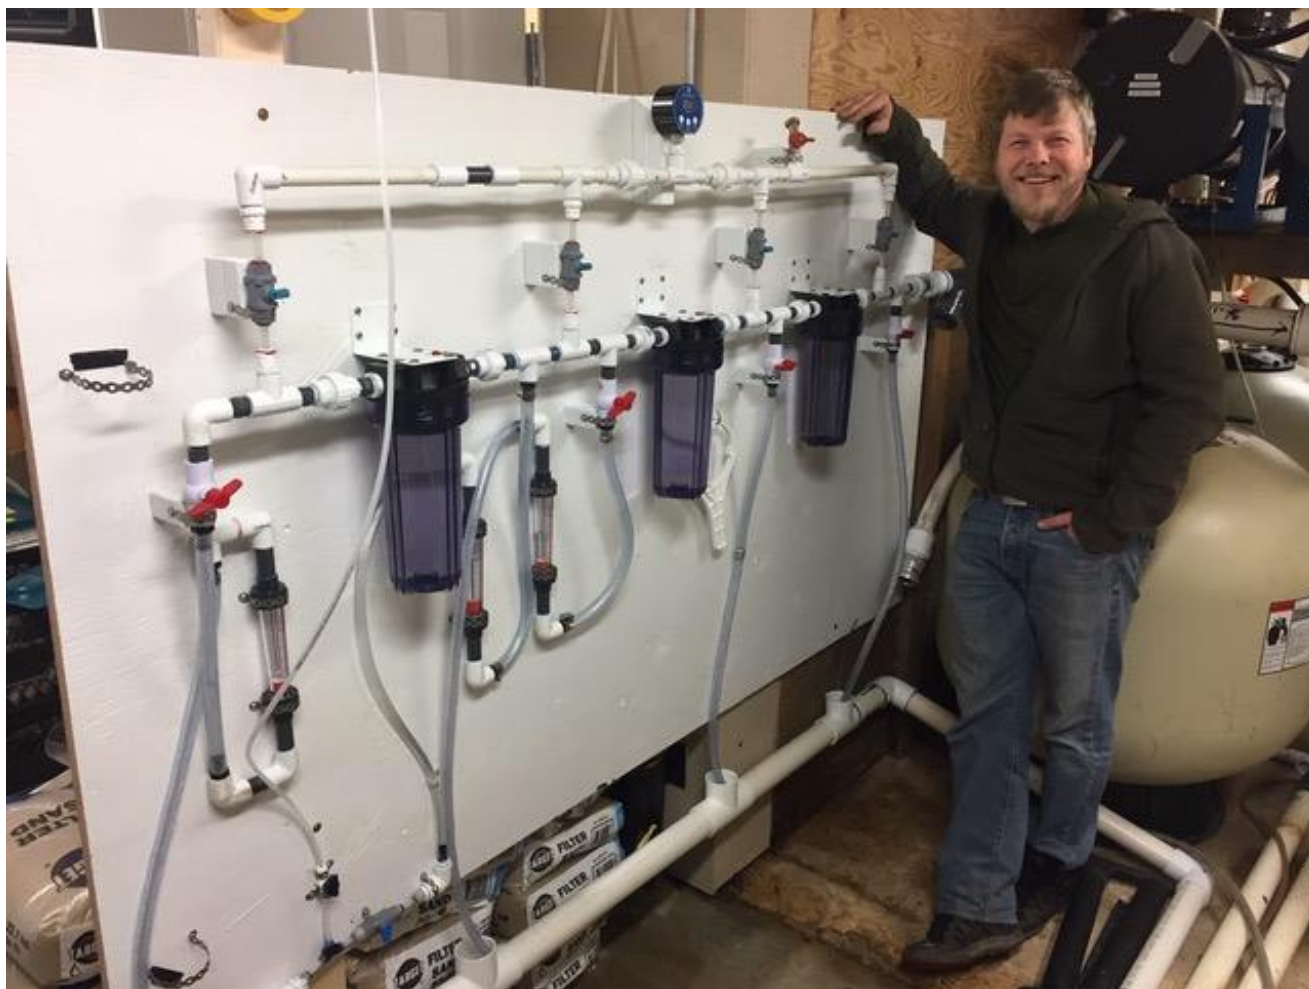
Figure 2: Pilot System Installed in GLID WTP (with IX Column removed for storage)

Figure 1 shows the process flow schematic of the pilot system arrangement. Figure 2 is a picture of the pilot system installed in the WTP (note the IX column is removed for storage and flow direction is right-to-left, mirror of the schematic flow direction).

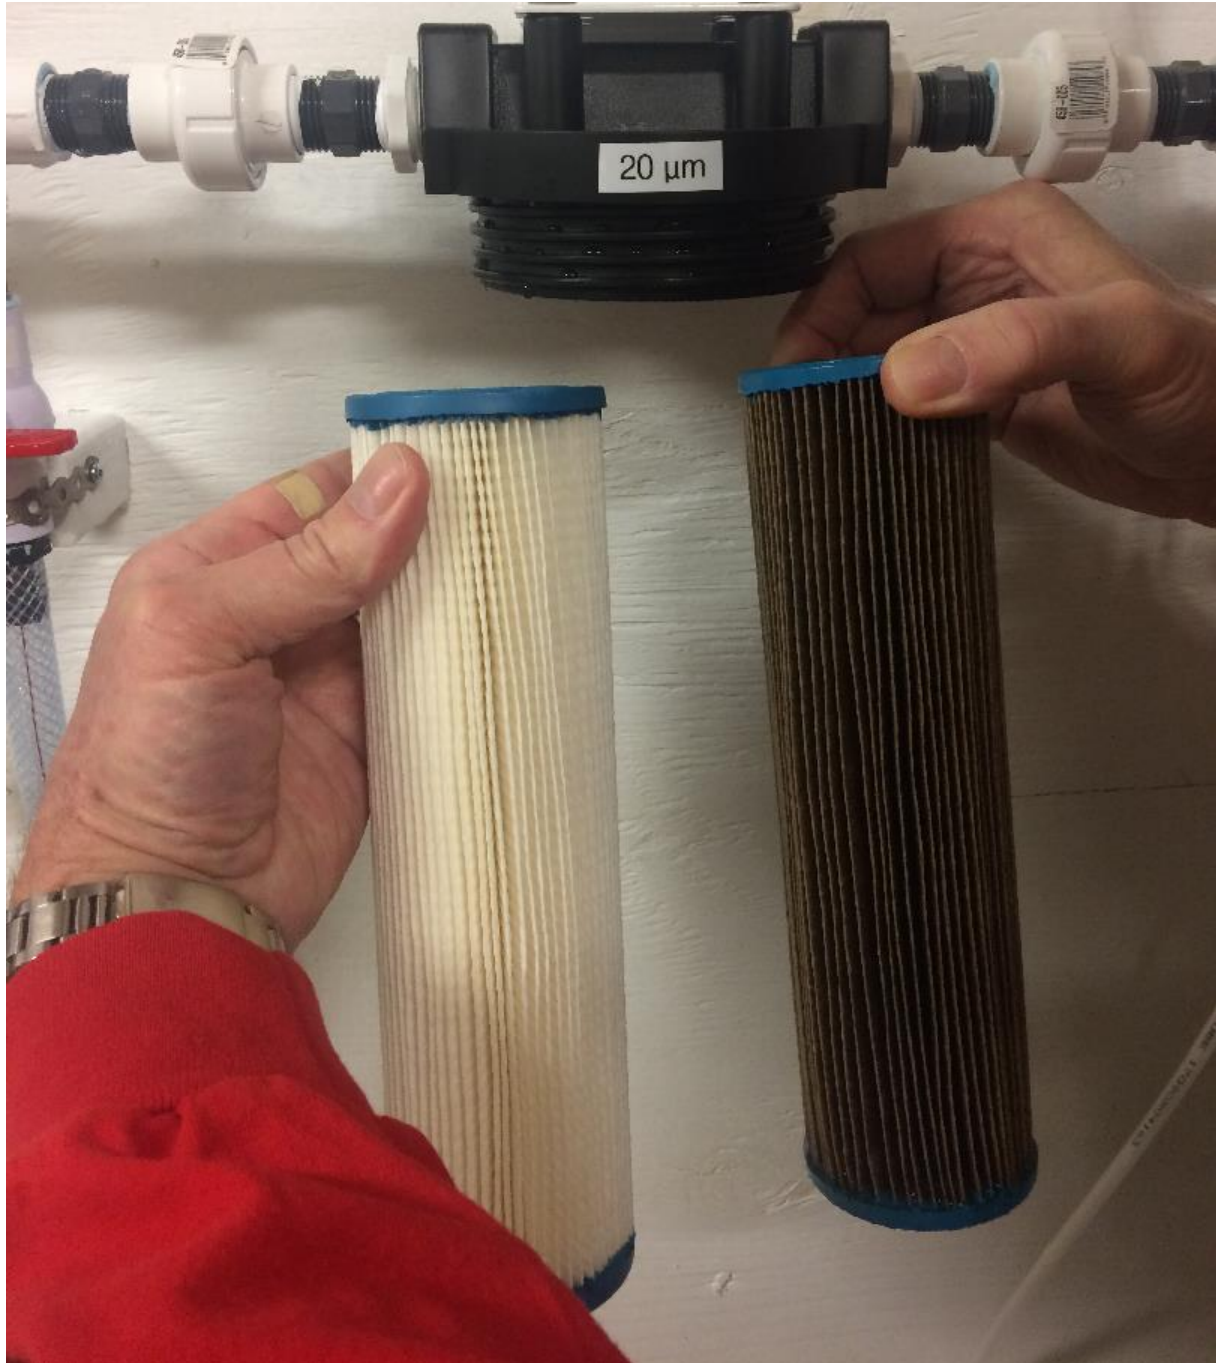
**Figure 3: 20 Micron Cartridge (clean vs dirty)**

From 25/01/2019 through 28/01/2019, CF1 cartridge was replaced with the washed 20 micron pleated cartridge and was allowed to run down to a low flow rate (as a result of full plugging of the CF3 filter discussed later in this report). It was found that even at greatly reduced flow rate, there was no improvement in turbidity through the 20 micron filter suggesting that the solids passing through are likely highly shear sensitive (easily broken down into smaller particles).

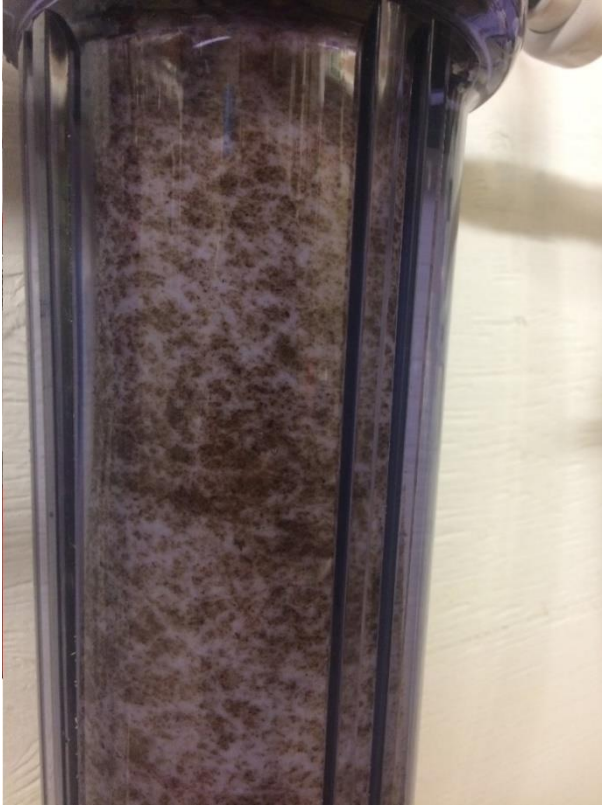
**Figure 4: 1 Micron Depth Cartridge Surface  
(28/01/2019)**

As can be seen in Figure 4 below, the 1 micron depth filtration cartridge started to become dirty, collecting some dark material on its outer surface while Figure 5 shows that it appears to have rather consistent dirt penetration through the depth of the cartridge.

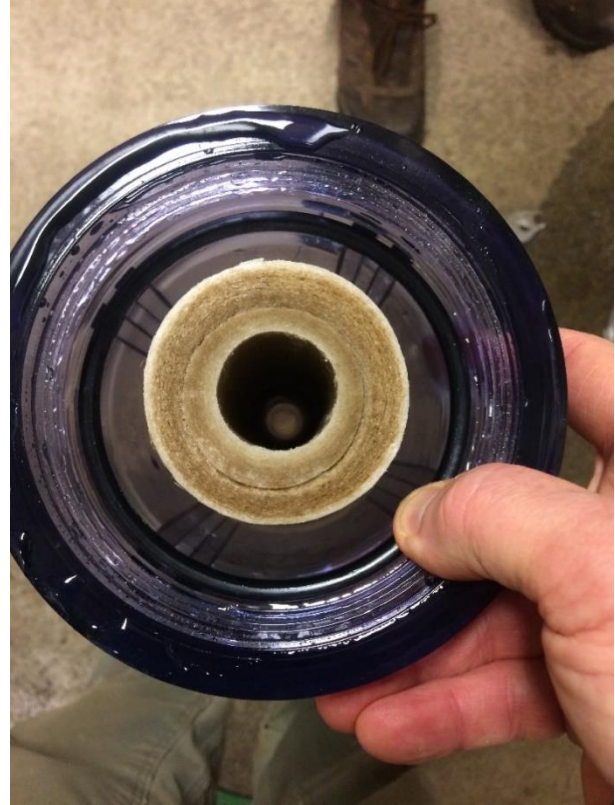
**Figure 5: 1 Micron Depth Cartridge Dirt Penetration  
(28/01/2019)**

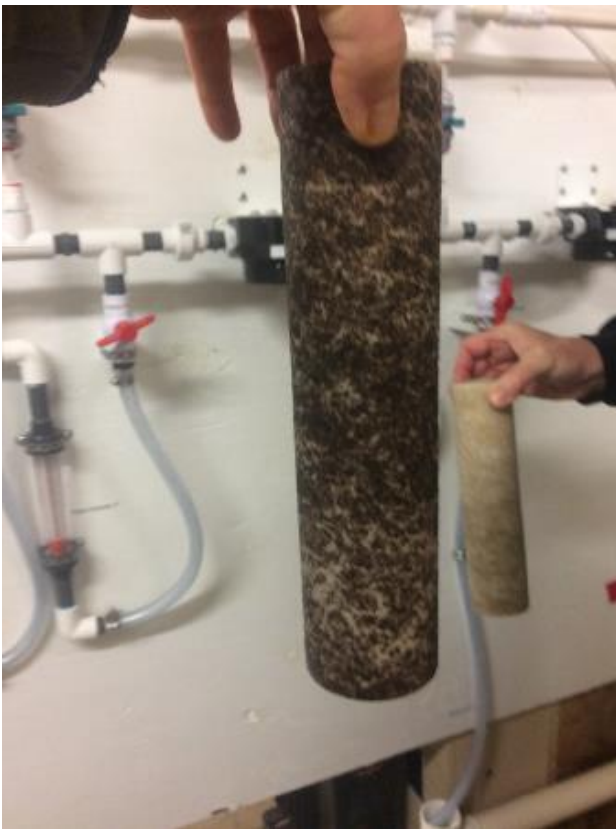
**Figure 6: 1 Micron Depth Cartridge Surface (from CF1, 30/01/2019)**

Table 3 shows the results from 28/01/2019 through 30/01/2019 where the CF1 and CF2 cartridges were run at high flow rate with 1 micron absolute depth filtration cartridges in both filter housings. At this high flow rate it was found that the first stage filter (CF1) showed a moderate rate of increasing pressure drop (plugging) indicating that it was capturing some solids but it still resulted in an increase in turbidity suggesting larger particles break-up and passage similar to the 20 micron cartridge. The second stage (CF2) 1 micron depth cartridge had no measurable plugging and moderate turbidity removal similar to the results of the 5 micron cartridge. This indicates that the turbidity is from particles primarily smaller than 1 micron size. Figures 6 and 7 below shows the dirty 1 micron nominal depth cartridges taken from the first stage (CF1) and second stage (CF2) filters (respectively). The dark brown dirt on the outside surface of the first stage filter appears to be indicative of organic matter.

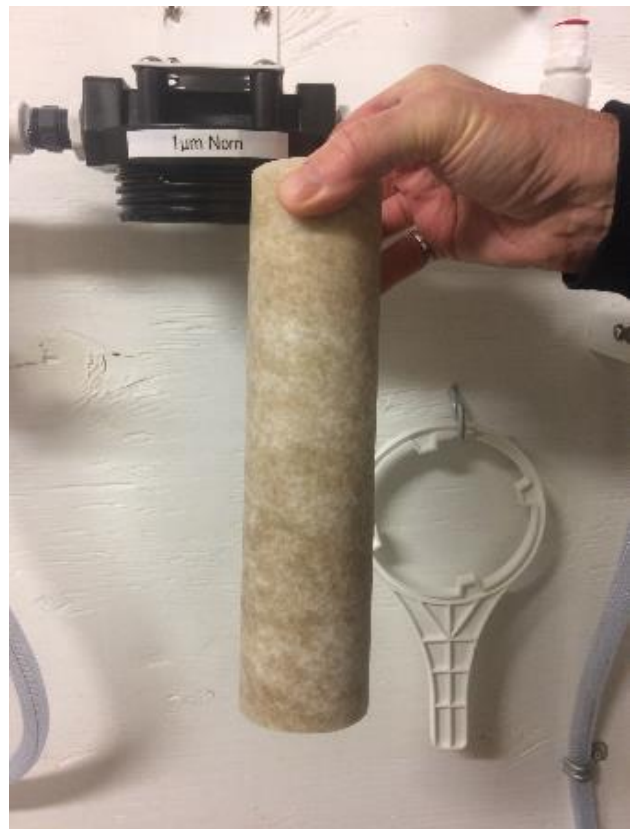
**Figure 7: 1 Micron Depth Cartridge Surface (from CF2, 30/10/2019)**

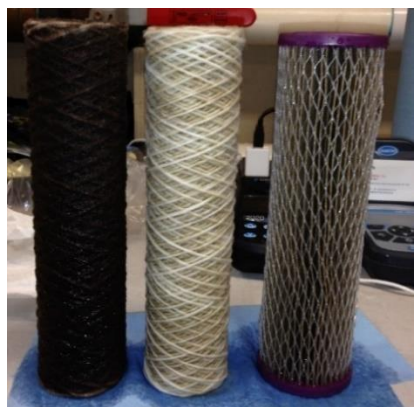
**Figure 8: CF1, 2 & 3 (06/02/2019)**

From 02/02/2019 through 11/02/2019 the first and second stage filters were run using 0.5 micron nominal depth filtration cartridges (string wound polypropylene). From 02/02/2019 through 06/02/2019 they were run at high flow rate and the first stage filter (CF1) did not exhibit any increase in turbidity (same as the 20 micron or 1 micron depth filtration cartridges at similar flow rate) and only developed a very gradual increase in pressure drop (plugging), while the second stage filter (CF2) provided a marginal reduction in turbidity and only very slight increase in pressure drop. Figures 8, 9 and 10 below show the dirt build-up in the CF1 filter during this run, while CF2 remained quite clear indicating that these filters are effective at capturing the organic solids material while any dissolved organic matter is able to freely pass through them.

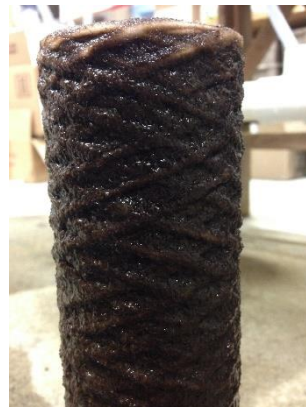
**Figure 10: CF 1 (06/02/2019)**

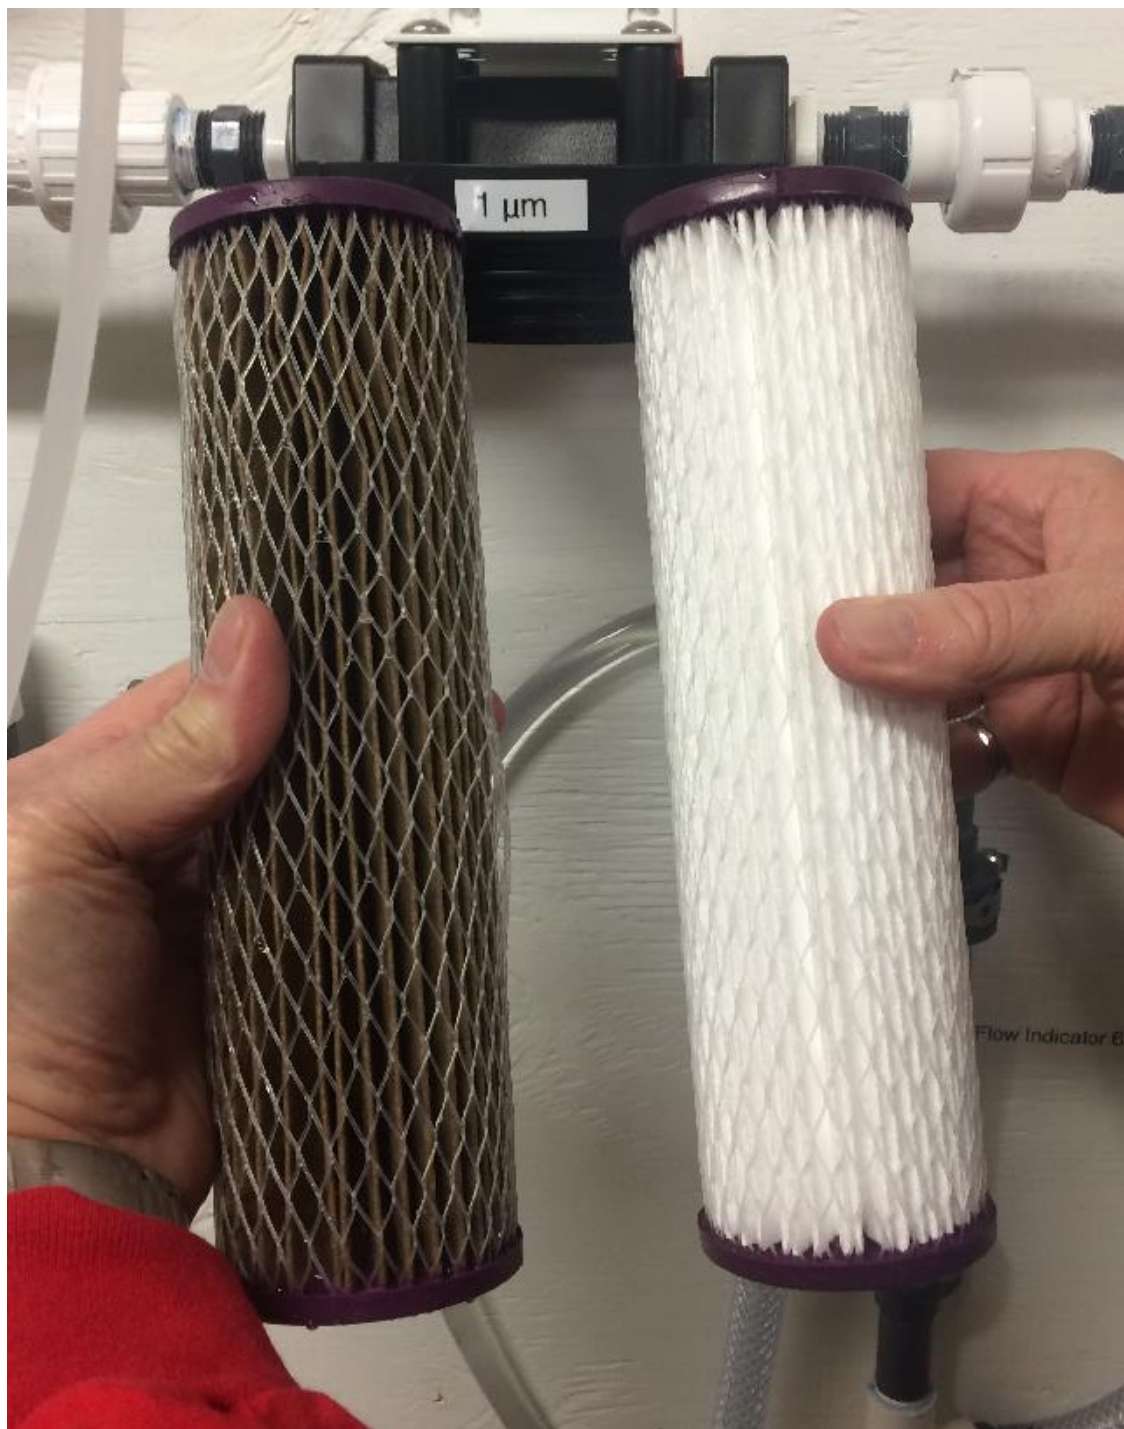
Figure 12: Dirty vs clean 1 micron absolute cartridge filter after run ending 21/01/2019

The cartridge filtration pilot results showed no change in the water pH passing through the filter cartridges as expected. There was a slight increase in apparent colour of the water passing through the 20 micron filter which agrees with its corresponding increase in turbidity due to possible break-up of organic particles. The 1 micron absolute cartridge filters provided a consistent slight reduction in apparent colour suggesting there was some small amount of organics solids removed, however, there was no appreciable change in the UVT or dissolved organics measurements, indicating that the cartridge filters did not retain any dissolved organics as expected. Figure 12 shows the dirty 1 micron absolute cartridge filter removed after its run ending on 21/01/2019 with a clean replacement filter next to it.

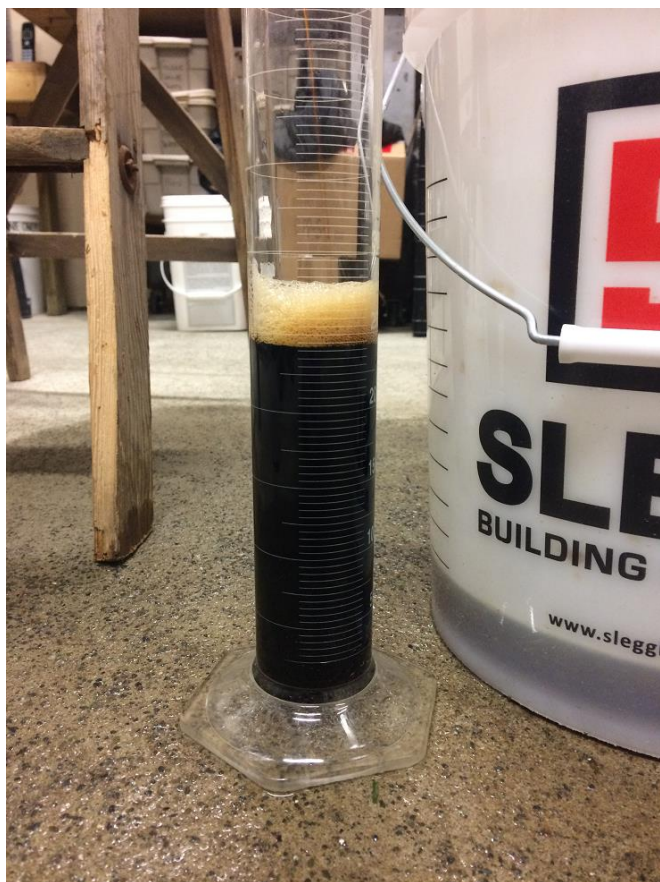
Figure 15: Waste regeneration brine after IX column run #1 (25/01/2019)
