Report on the 2015 Saratoga Beach Groundwater Monitoring Program

10 February 2016

Prepared for
Comox Valley Regional District
Courtenay, BC

Prepared by
Payne Engineering Geology
1230 Maple Road, North Saanich, BC, V8L 5P7

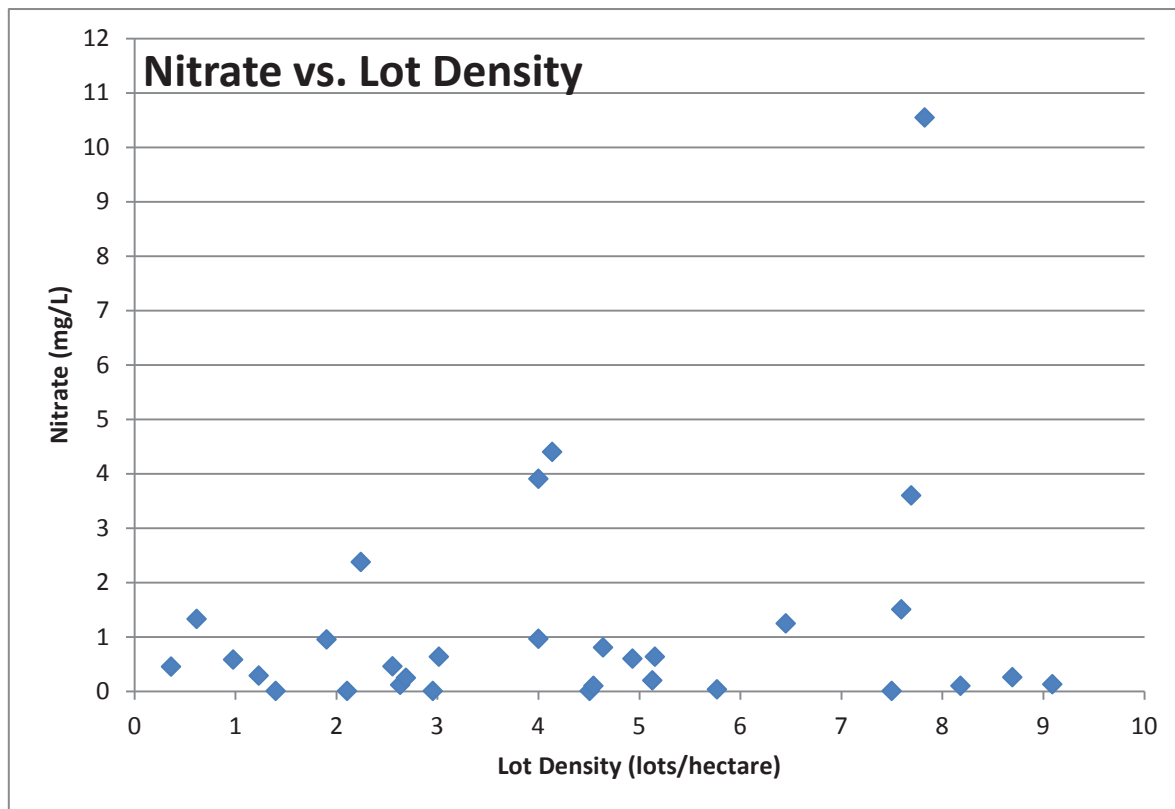
To analyse lot size versus groundwater quality, we looked at the average lot size (or septic system density) immediately up-slope from each of the monitoring wells. The following graph shows groundwater nitrate concentrations versus lot density.

For this project, the water quality objective for nitrate is 3.0 mg/L. This graph shows that all monitoring wells with a nitrate concentration exceeding 3.0 mg/L were located down-slope from areas with a higher residential density, with four or more lots per hectare. This graph also shows that the monitoring wells located down-slope from lower density areas, with fewer than 4 lots per hectare, met the water quality objective. This shows a clear relationship between lot density and nitrate concentration. This is consistent with published research showing how residential lot size affects concentrations of nitrate in groundwater (Hantzsche and Finnemore, 1992; Gardner and Vogel, 2005).

1. **SMALL LOTS:** Areas with smaller residential lots, especially lots smaller than 0.25 hectares, had an implied onsite system failure rate of 33%, compared with 0% for areas with lots larger than 0.25 ha. While this is only based on water quality in 32 locations in the spring of 2015, the results indicated a clear influence of lot size.

The first such factor is the lot density or lot size. The septic system failure rate was higher, 33%, in areas with lot sizes of 0.25 hectare or smaller. In contrast, in areas with an average lot size of larger than 0.25 hectares, the detected failure rate is zero.

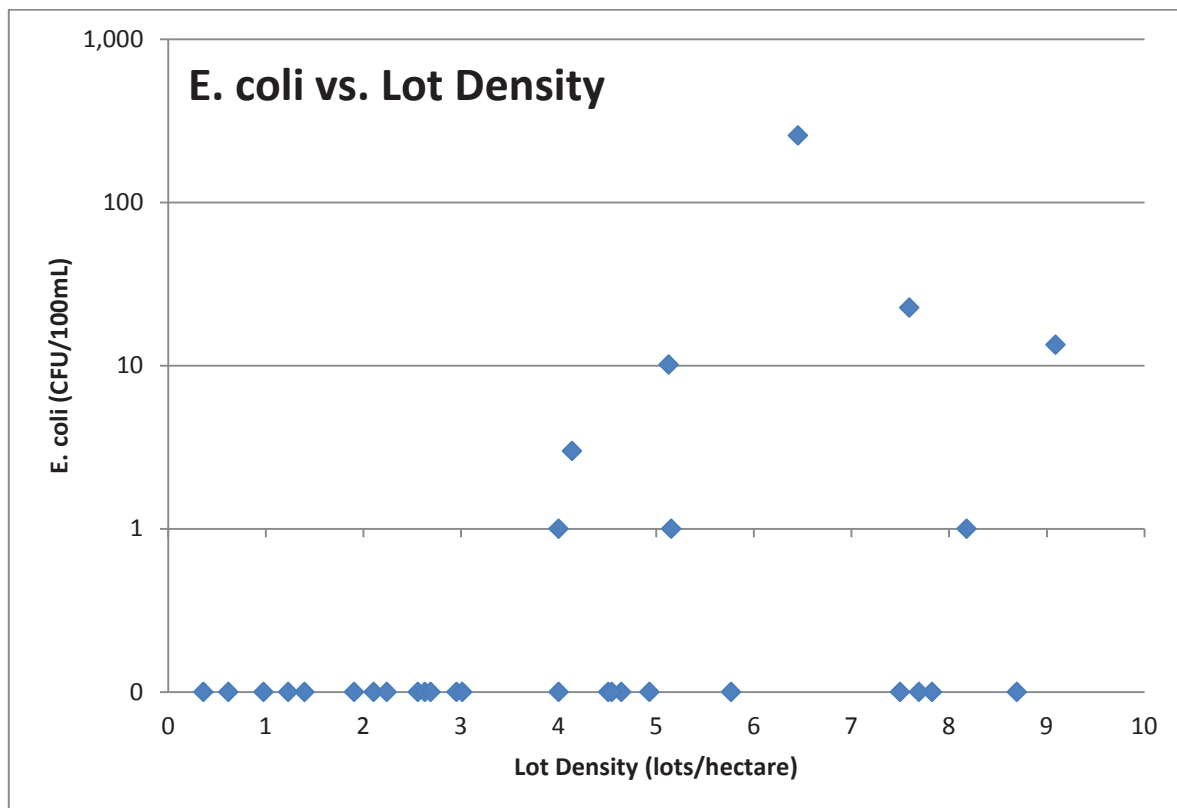
The following graph shows groundwater E. coli density versus lot density.

This graph also shows how groundwater quality is influenced by lot density. For this project, the water quality objective for E. coli is less than 14 CFU/100mL. This graph shows that the wells that exceeded this value were located down-slope from areas with a lot density of more than 6 lots per hectare. Similarly, the wells located down-slope from lower density areas, with fewer than 6 lots per hectare, met the project objective.

Also, this graph shows that no E. coli bacteria were detected in any of the wells located down-slope of areas with a density of fewer than 4 lots per hectare.

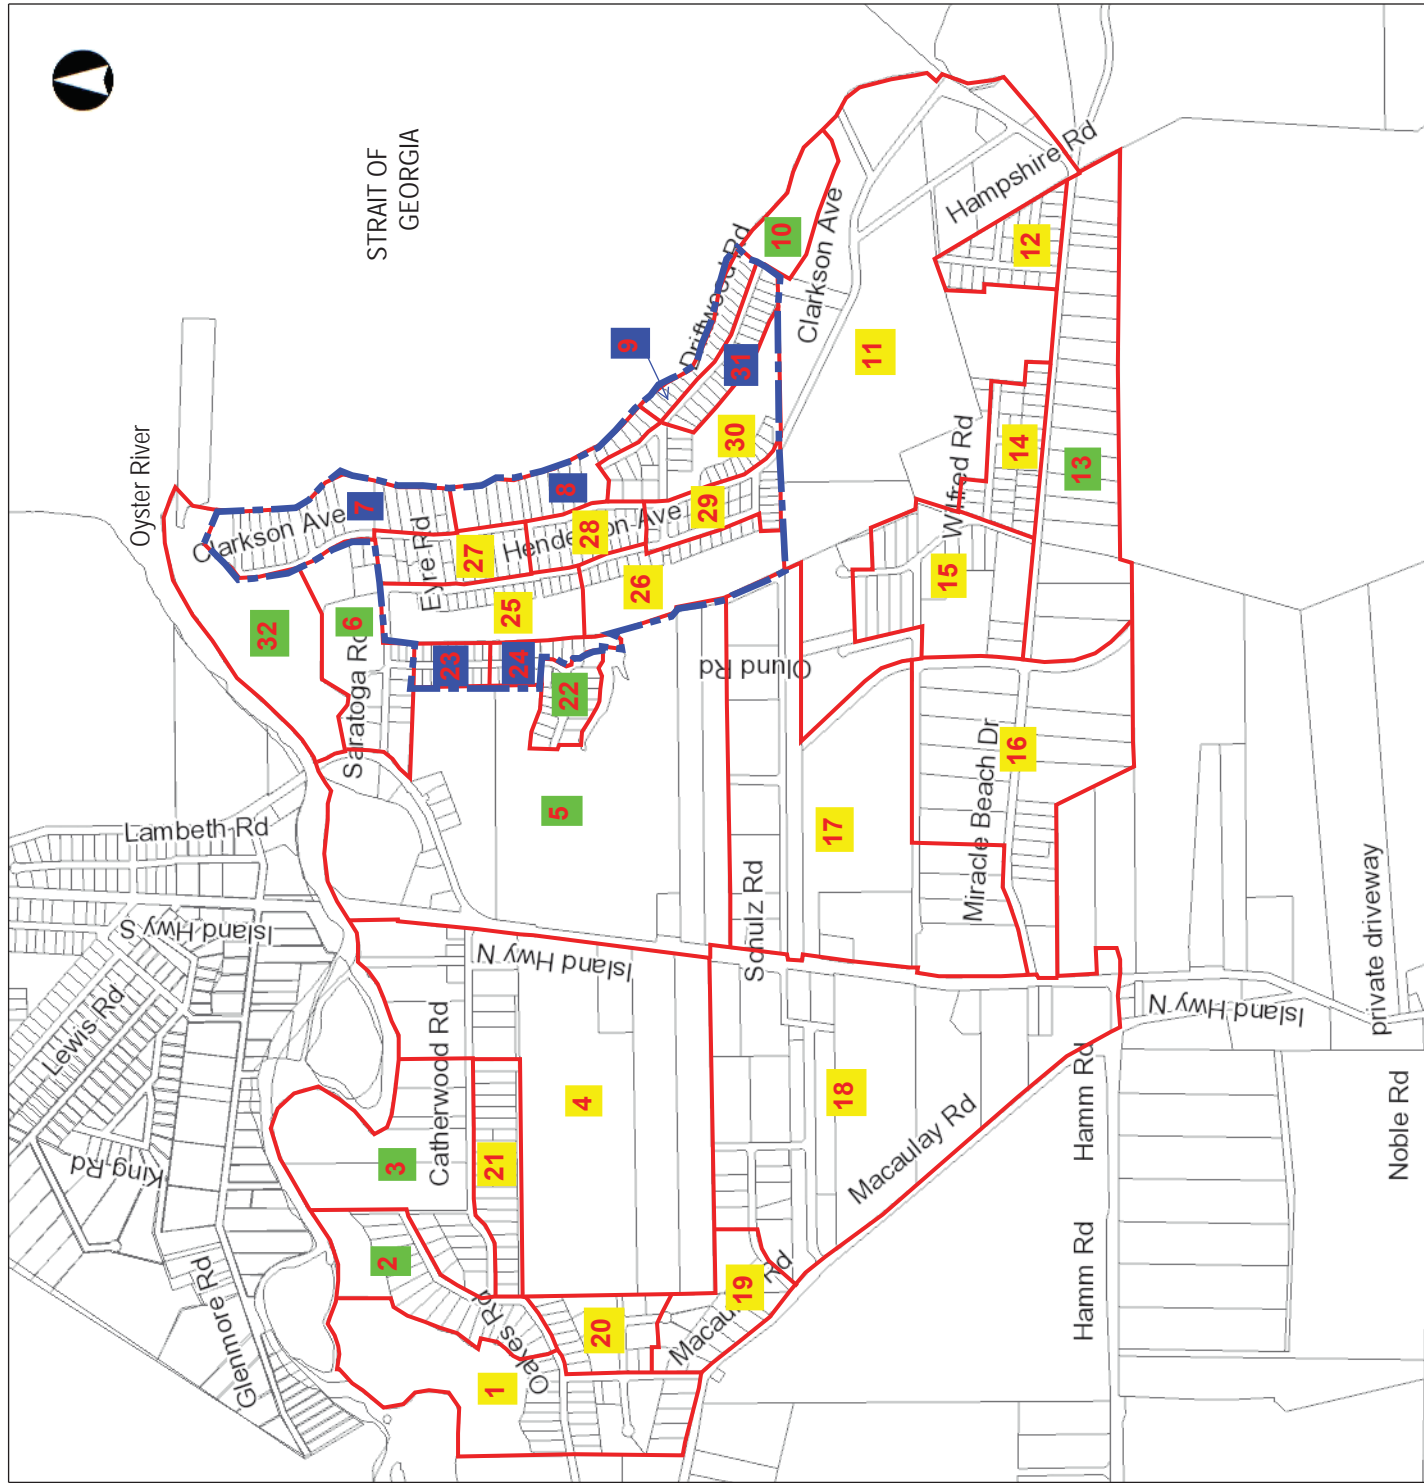
- Digital Road Atlas - Labels
- Integrated Cadastral Fabric
- Outline of Sub-Areas
- Sub-Area Number
- Failed wells
- Water table shallower than 100 cm
- Water table deeper than 100 cm
- Designated Area - Note (3)

Based on the location of the problem area, and based on locations of higher density areas with a shallow water table, Figure 5 identifies a *Designated Area* that, in our interpretation, has the least favourable conditions for on-site sewage systems. One implication of this is that, if the Regional District decided to connect some existing systems to a new communal sewage treatment system, these lots would be the higher priority for connection.

Based on these results, Figure 5 shows an interpreted or inferred *Designated Area*. This is the area with the least favourable conditions for onsite sewage systems. Within this *Designated Area*, the overall failure rate, based on methods of this study, was 6 out of the 12 monitoring wells, for a 50% failure rate. This is a significant failure rate with reference to the Building Canada Fund standard listed above.

However, this study found a failure rate of 50% in the least favourable (or problematic) areas, particularly the *Designated Area* (Figure 5). The following table is a summary of the onsite system failure rates, for different areas or sub-areas, based on this study.
