To: Mr. Bill Uhrich  
Simcic + Uhrich Architects  
Suite 230 3 West 3rd Avenue  
Vancouver BC V5Y 3T8

Submitted: May 18, 2017 by  
RDH Building Science Inc.  
730 Grant Avenue #208  
Courtenay BC V9N 2T3

RDH Building Science Inc. (RDH) was retained by Simcic + Uhrich Architects to undertake a targeted investigation of the of the wall assembly located at 3850 Central Rd, Hornby Island, BC.

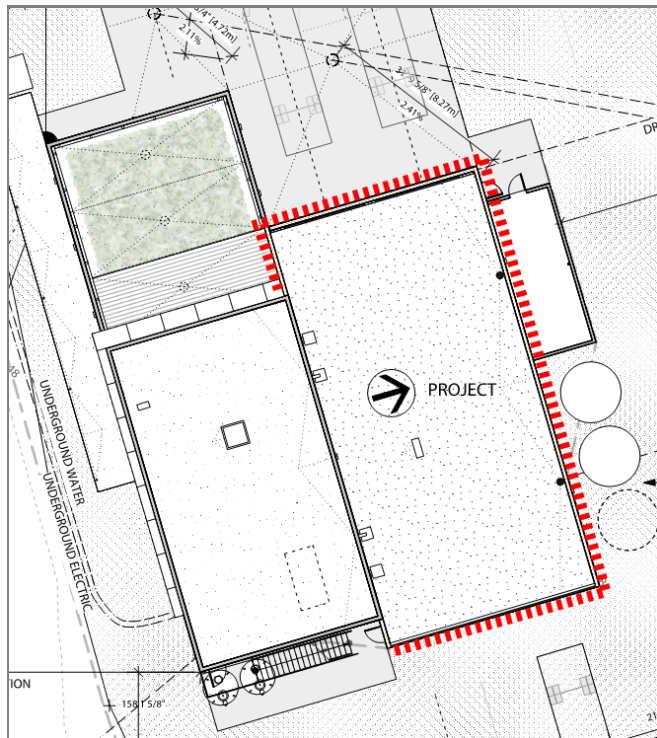
*Figure 1.1  
Building footprint with the  
Apparatus Bay area reviewed  
highlighted.*

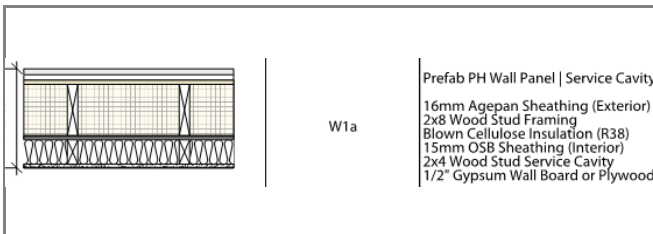
*Figure 2.3*

As reported to us, the walls of the Passive House equivalent portion of the fire hall are constructed from premanufactured wall panels as shown in the figure below. The air barrier and vapour barrier are formed by the OSB interior sheathing with taped joints between panels and joints in the OSB sheets. An Ampatop Aero synthetic water resistive barrier was site installed over the exterior Agepan sheathing. We did not review these walls during our site visit.

*Premanufactured wall panel  
to exterior sheathing.*
