# Comox Lake Watershed Protection Plan

UPDATED 2022

Comox Lake supplies the Comox Valley Regional District with its main source of drinking water. The objective of this Watershed Protection Plan is to guide the management of the Comox Lake Watershed for the long-term protection of drinking water at the highest possible quality. The plan was developed in close consultation with the Comox Lake Watershed Advisory Group which is comprised of land-owners, regulators and technical advisors. A risk assessment was conducted to update both natural and human-caused risks in the context of a deep-water intake in Comox Lake. This assessment formed the basis of fifty-four recommendations that are intended to act as a road map to a comprehensive watershed management program.

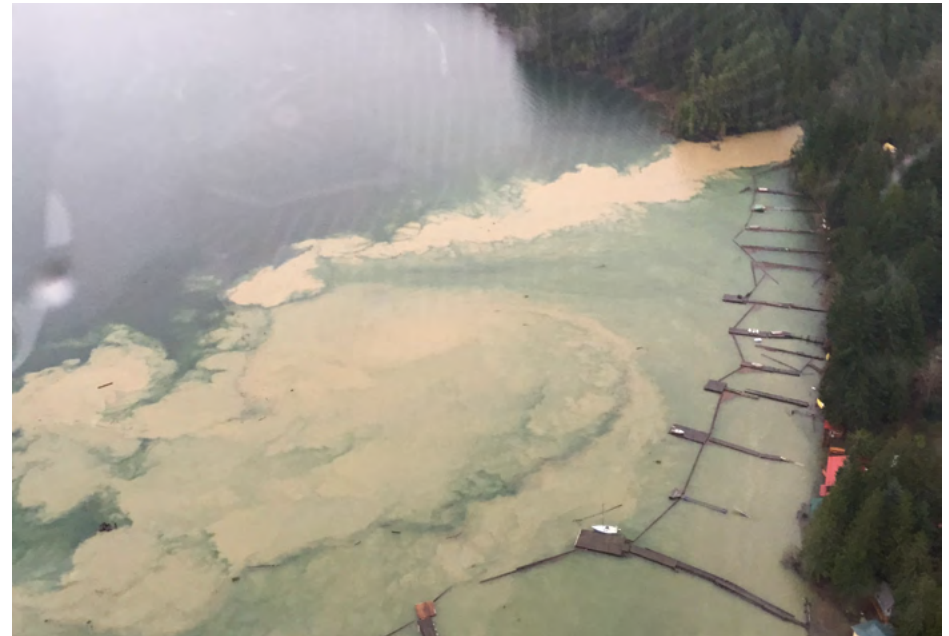
It is important to note that turbidity events may or may not be associated with elevated bacterial counts depending on the source of the particulate matter. If the turbidity is caused by inorganic soil erosion there may be no associated pathogenic bacteria, despite the high readings, and thus no direct threat to human health. Another risk posed by the sediment represented by elevated turbidity is that it may interfere with or disrupt the disinfection process allowing the survival of pathogens in the distributed water. This risk may be reduced if the sediment is largely inorganic in nature, which is the case in Comox Lake.

*Perseverance Creek entering Comox Lake, December 11, 2014*

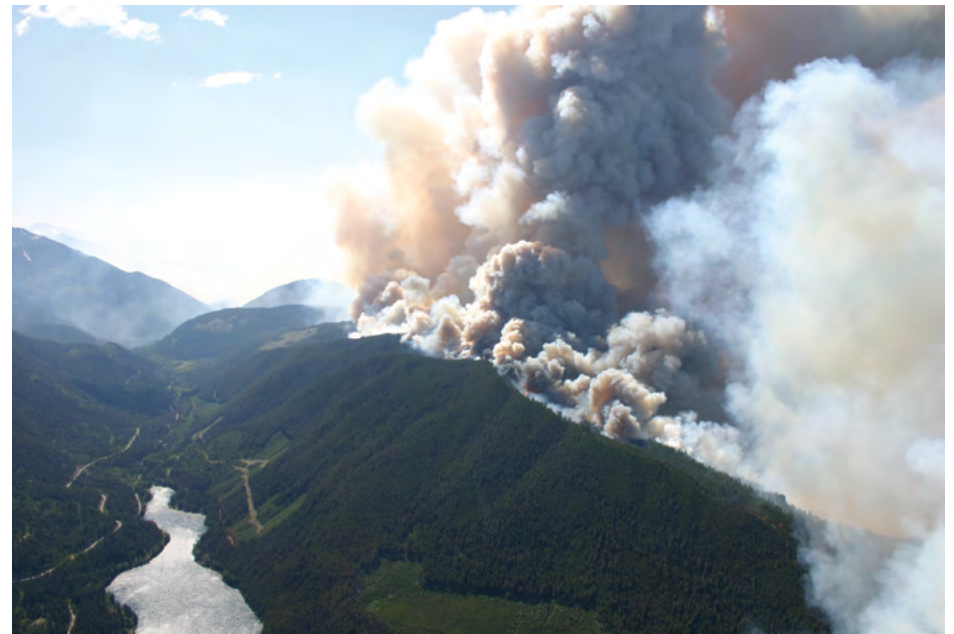
*Wildfire can lead to soil erosion which may contribute nutrients and turbidity to a water supply.*

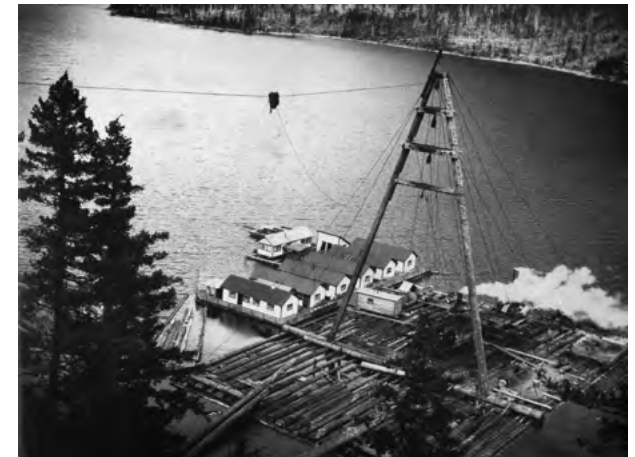
Between 1929 and 1934 the shores of Comox Lake were logged using a floating A-frame about 170 feet high. The A-frame was both harvester and camp. It was made of rafts of logs each 60 by 150 feet and accommodated 200 men in addition to a commissary, cookhouse, office, and blacksmith shop. The A-frame itself was made of timbers 220 feet long— massive individual Douglas-fir trees harvested from the watershed. It

allowed the loggers to reach about 1500 feet up the slope from the lake, so only the lower slopes of the lake were initially logged. It was an economical logging method during the Depression when every dollar counted.

*Floating A-frame – Comox Lake*

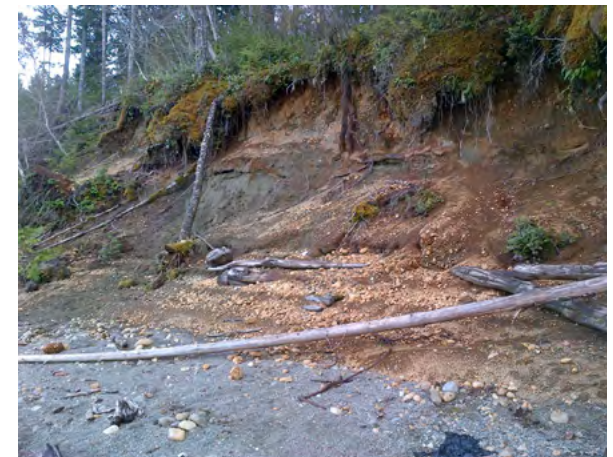
*Eroding shoreline at Cumberland Lake Park Campground.*

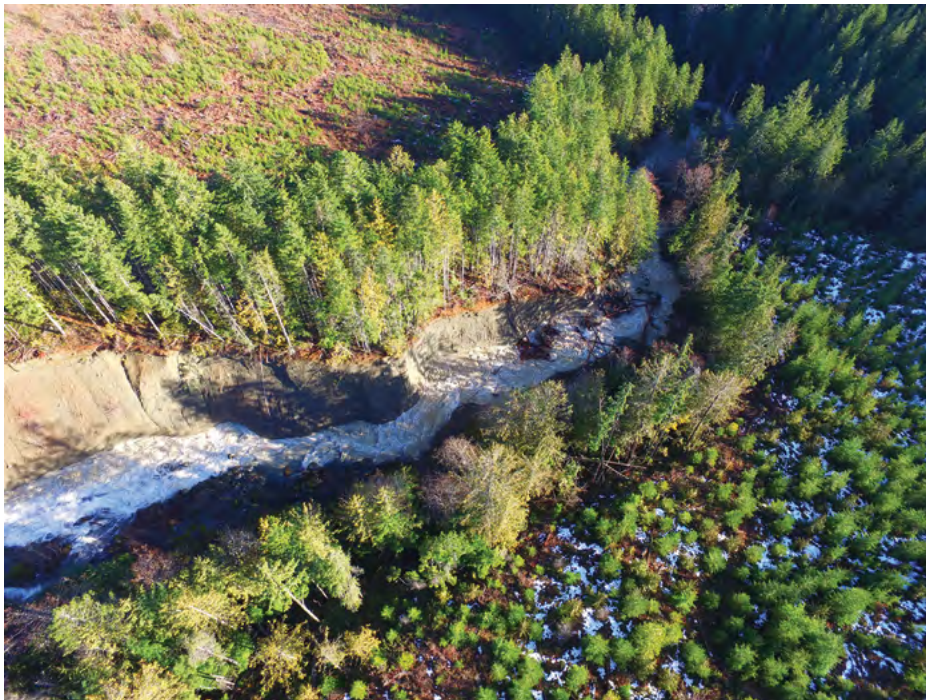
*Bank erosion in Perseverance Creek, January 28, 2016.*
